Area 2 – During Construction

Area 3 – During Construction

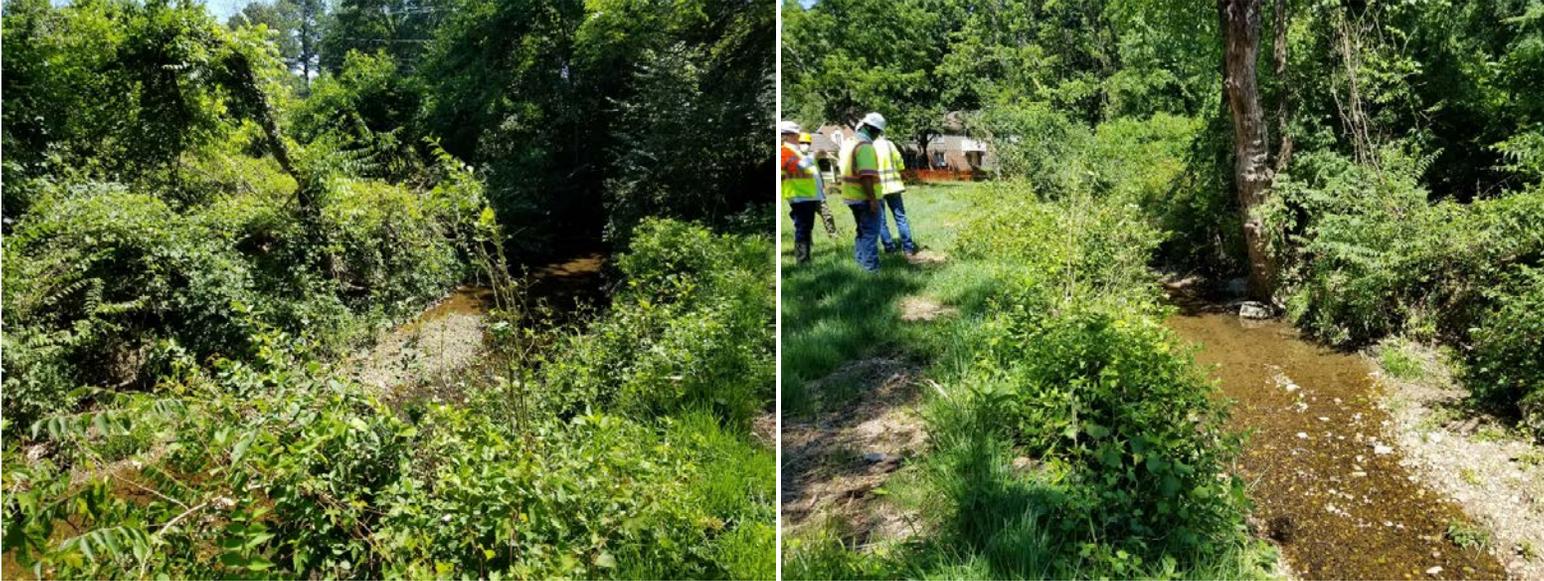
Area 1 required minimal restoration which involved relocating a mid-channel bar to the left bank. A bar is an area of sediment deposition. The banks on this part of the stream had been destabilized by erosion. Several dead/dying trees were removed and their stumps and roots were used to stabilize the stream bank.

After Construction & Stabilization, June 2020

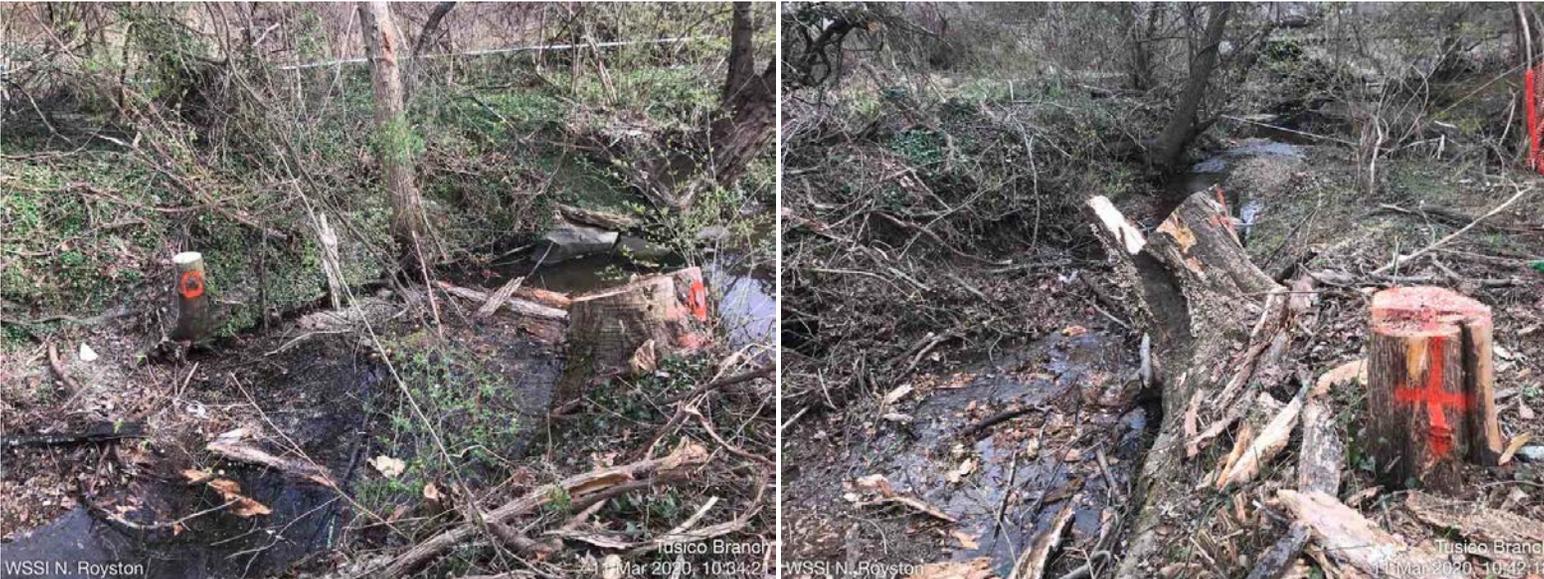
At the beginning of construction, March 2020

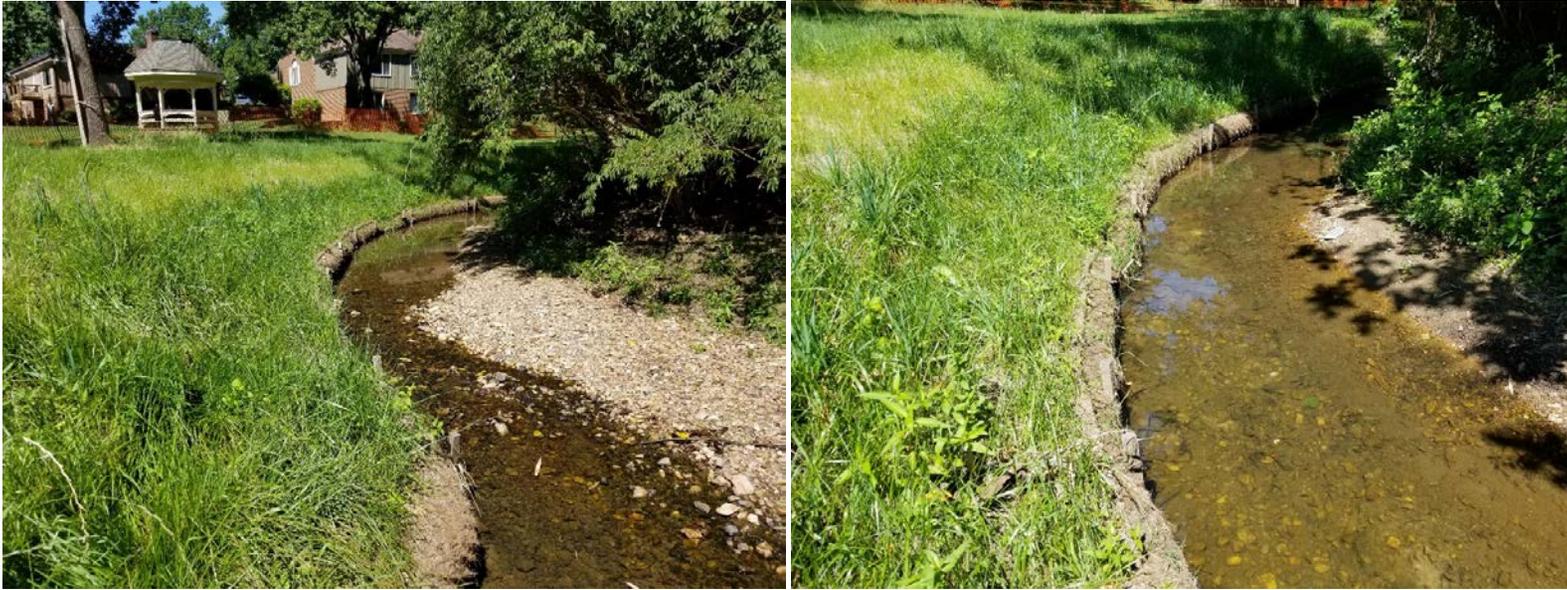
Area 2 included regrading of a severely eroded stream bank and placement of a natural fiber roll reinforcement at the bottom of the bank slope. Heavily eroded stream banks with vertical faces will continue to erode, while properly graded stream banks are more resistant to erosion.

After Construction & Stabilization, June 2020

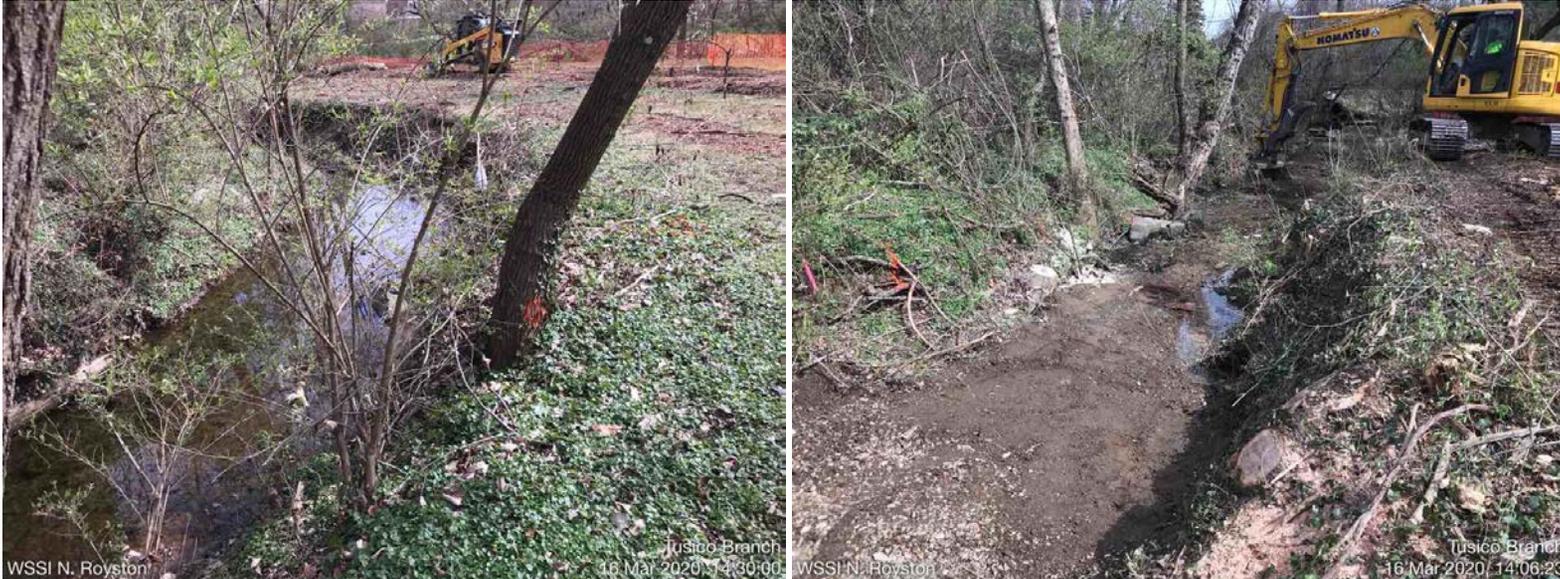
At the beginning of construction and just after tree removal, March 2020

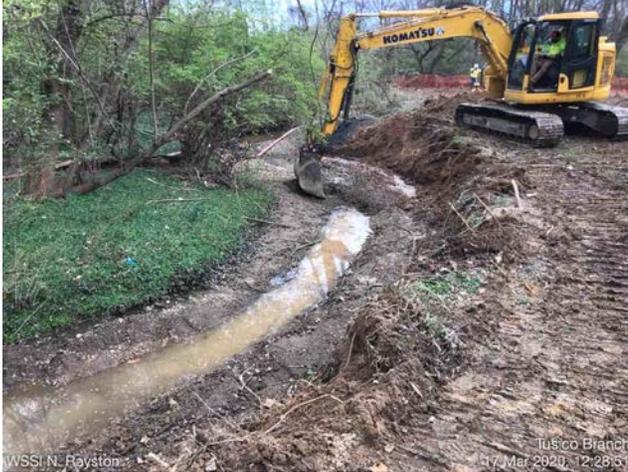
Initial regrading of the bank

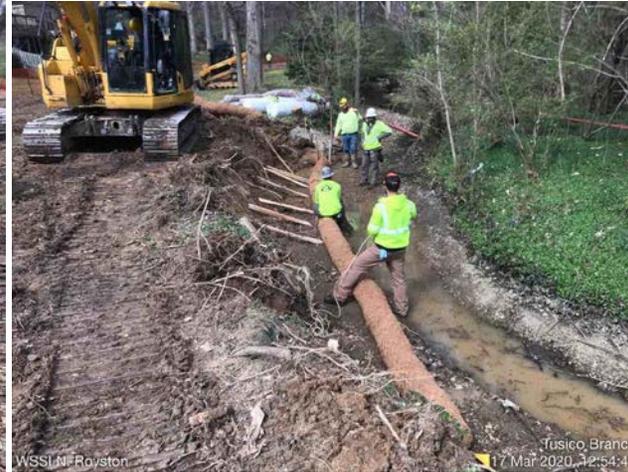
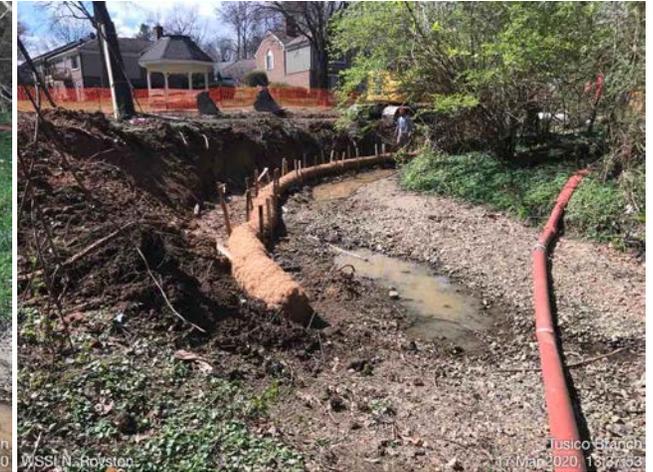
Placement of natural fiber roll

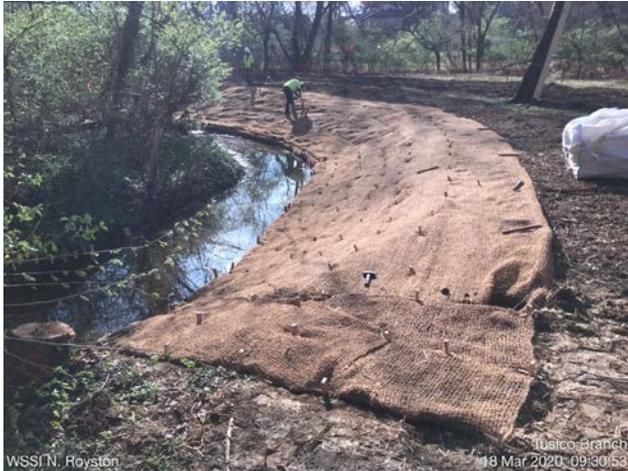
Placement of natural fiber stabilization blanket

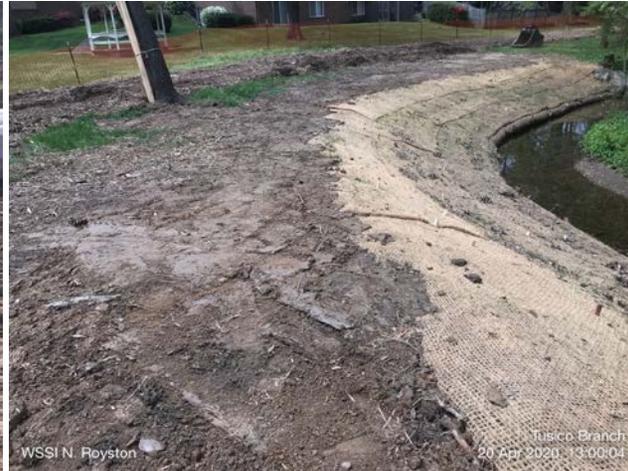
Restoration of the surrounding area.

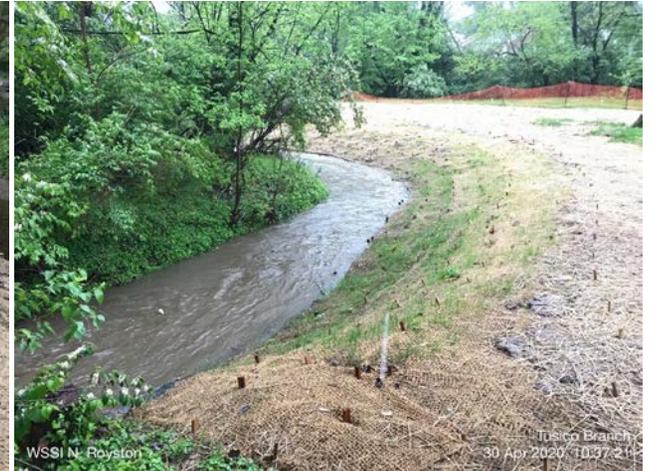
Stream levels following heavy rains.
Erosion is being controlled.

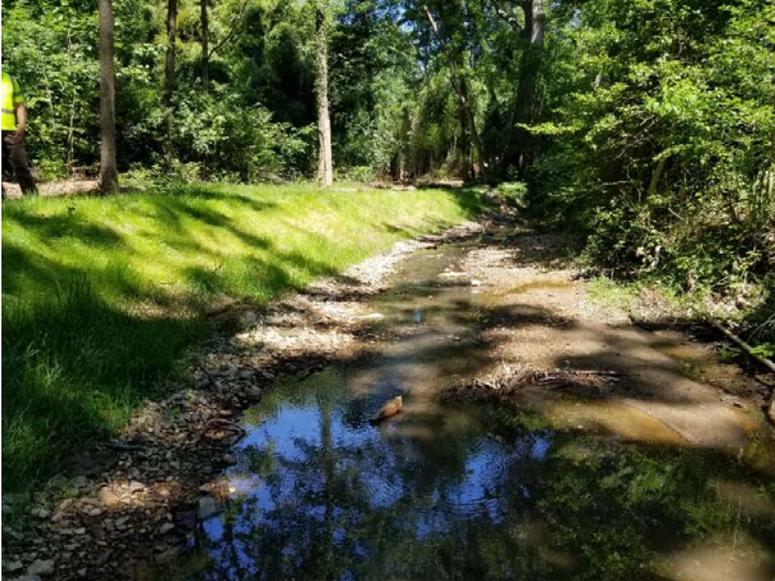
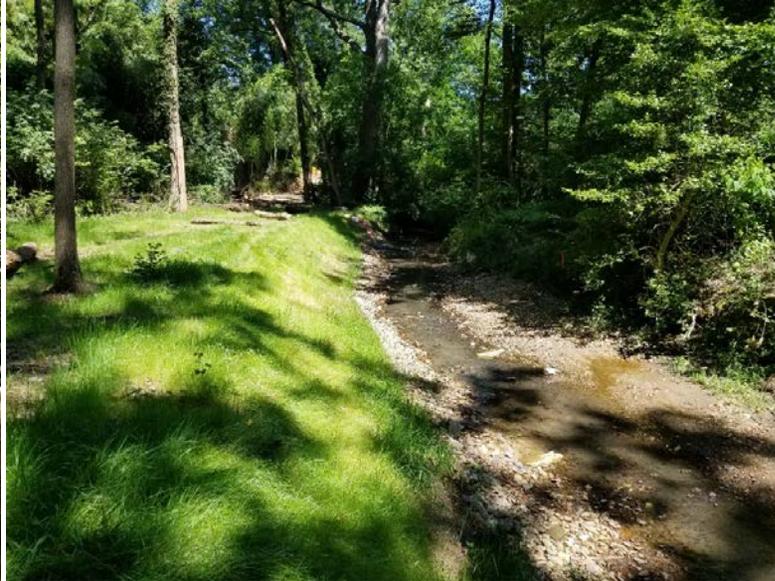
Area 3 included regrading and stabilizing a second area where streambanks had become severely eroded.

After Construction & Stabilization, June 2020

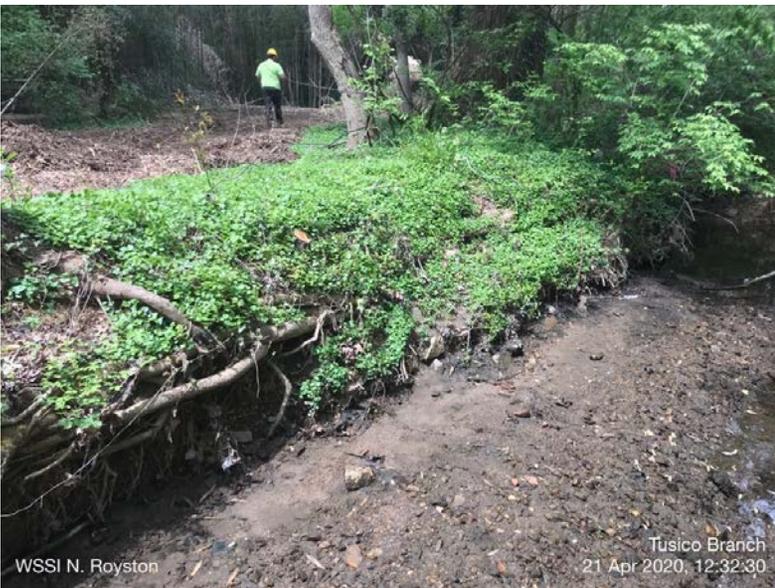
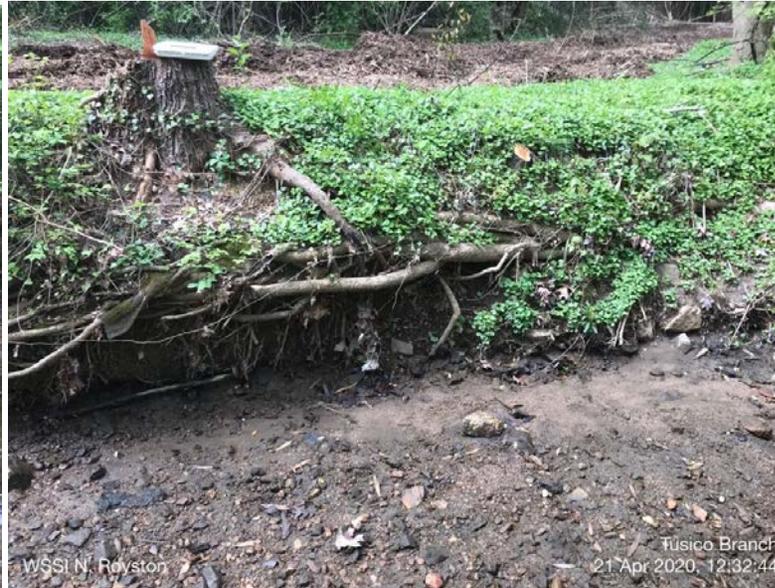
Initial conditions, April 2020

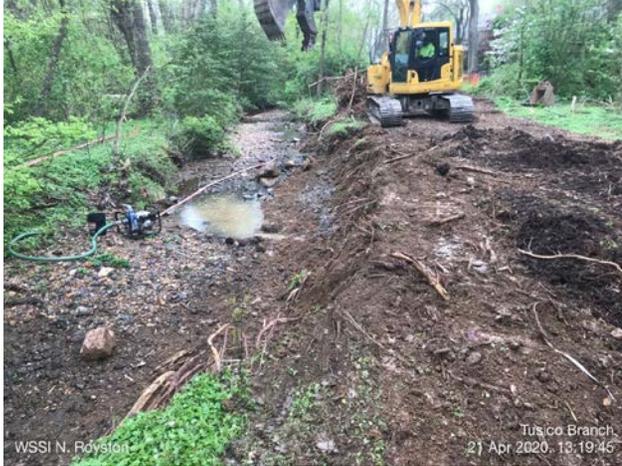
Initial grading

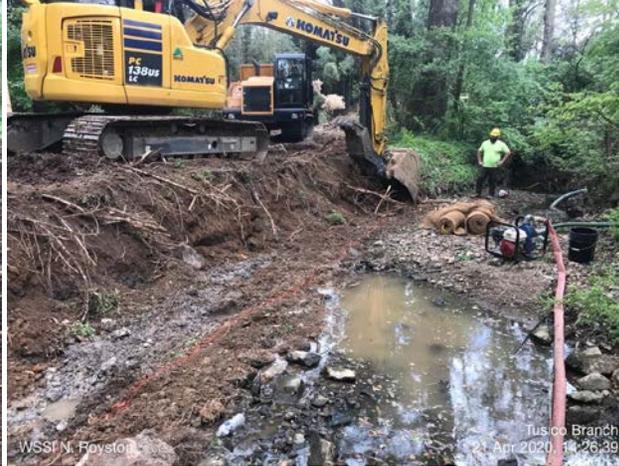
Initial Grading

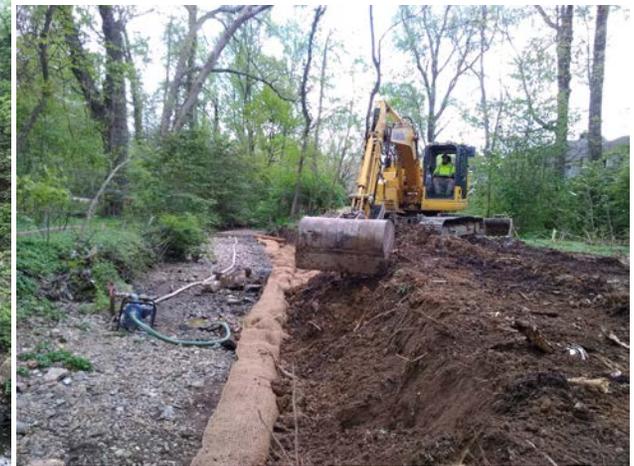
Placement of natural fiber roll and grading.

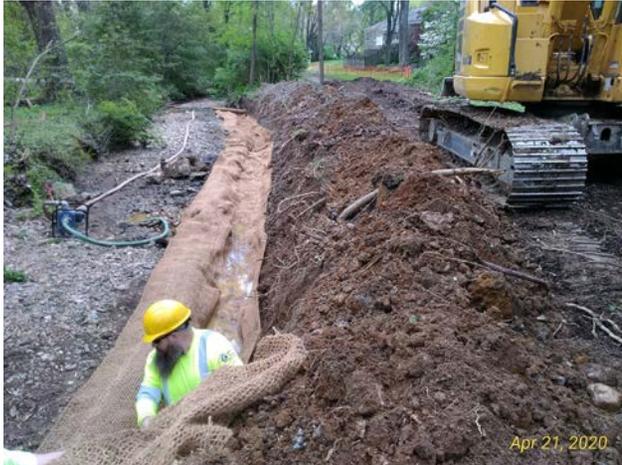
Placement of stabilization matting

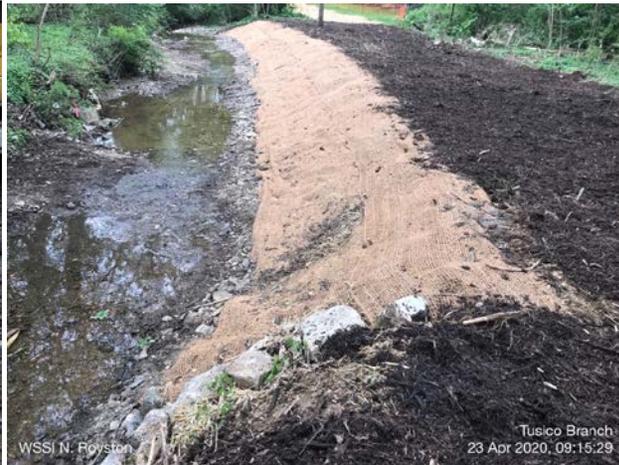
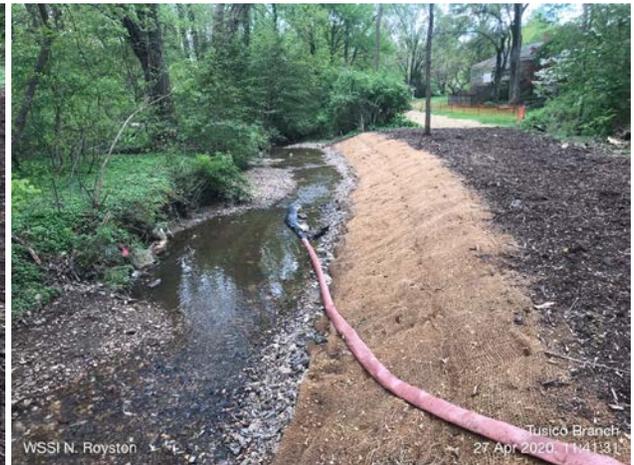
Grading and stabilization matting installed, restoration of surrounding work areas complete.

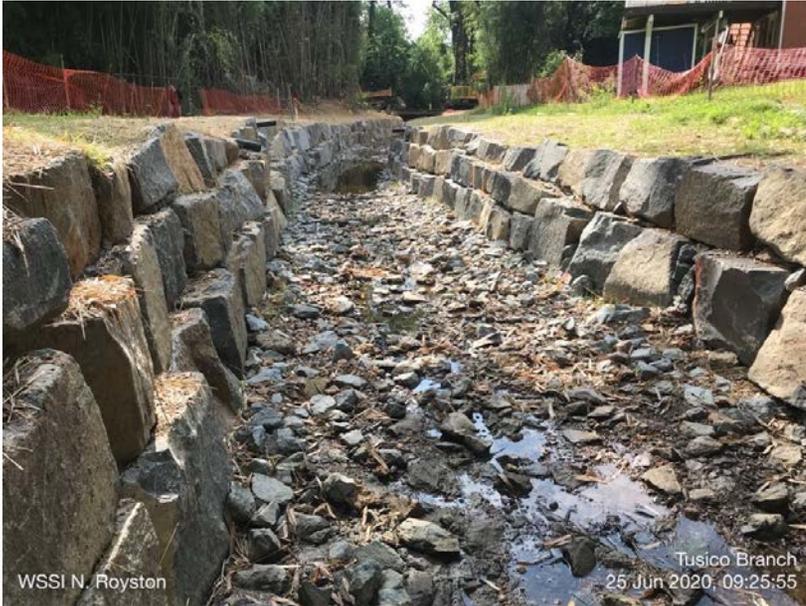
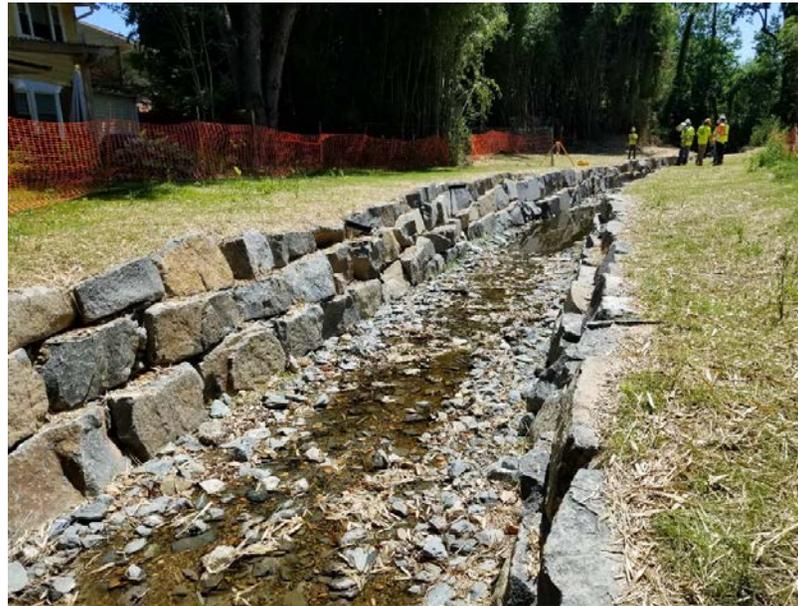
After Construction, Stabilization In-Progress, June 2020

Stacked boulder wall is non-erodible. Cobble stream bed provides for aquatic habitats and additional erosion protection.

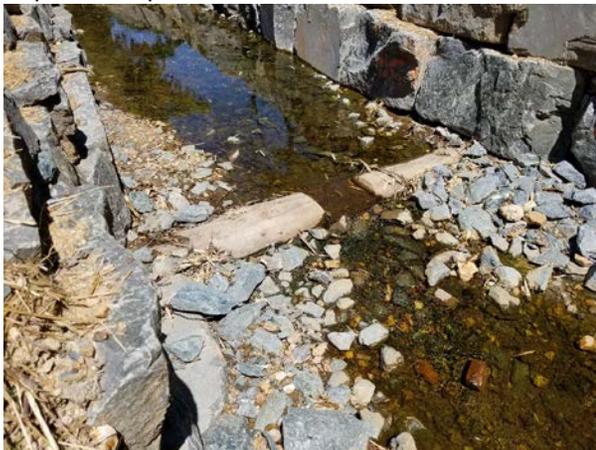
One of five log drops, which create areas of pooling and slow flowing water, which provide improved aquatic habitats.

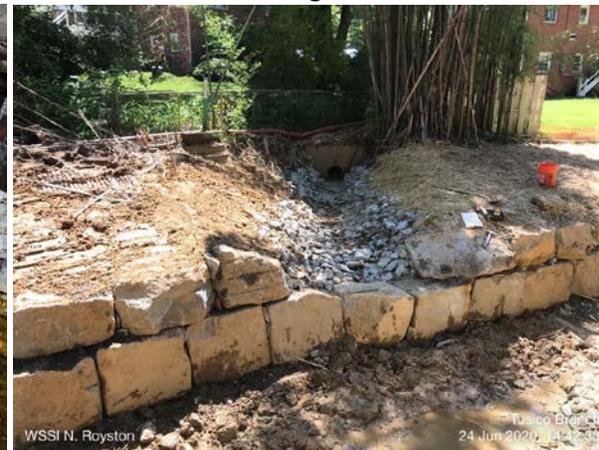
Stabilization of an existing storm outfall

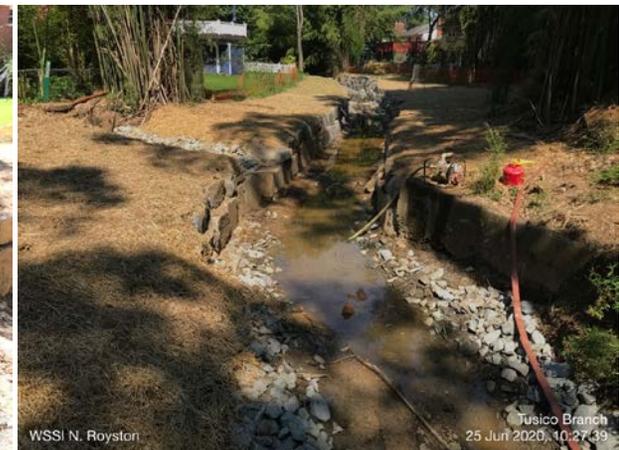
Overall view of Area 4

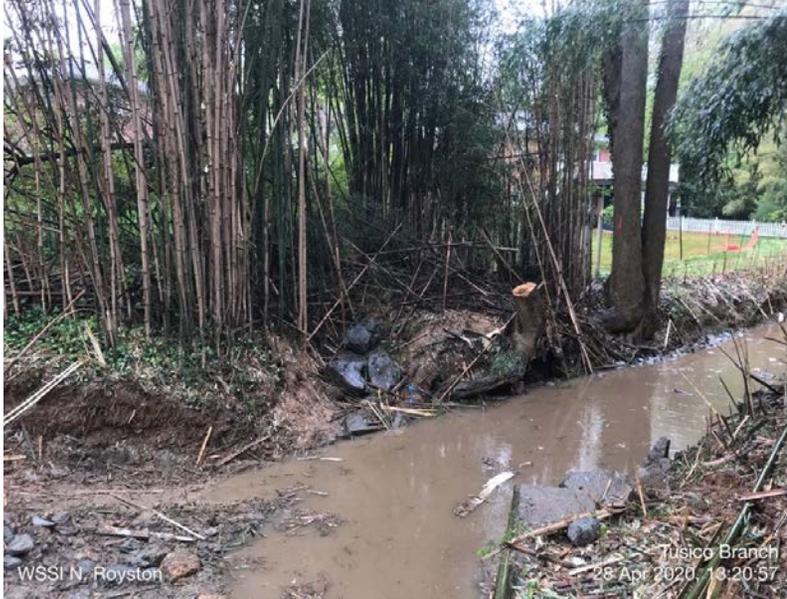
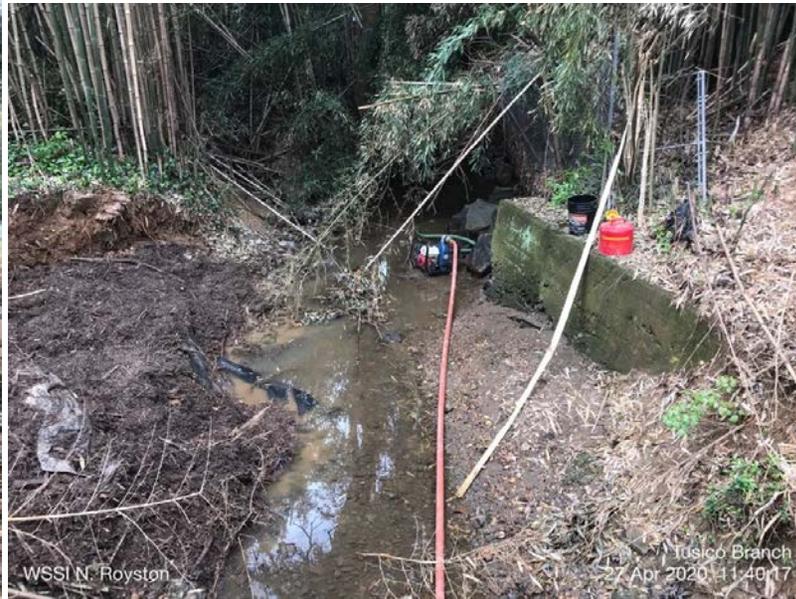
Area 4 – Initial Conditions, April/May 2020

Failing storm outfall and eroding streambanks.

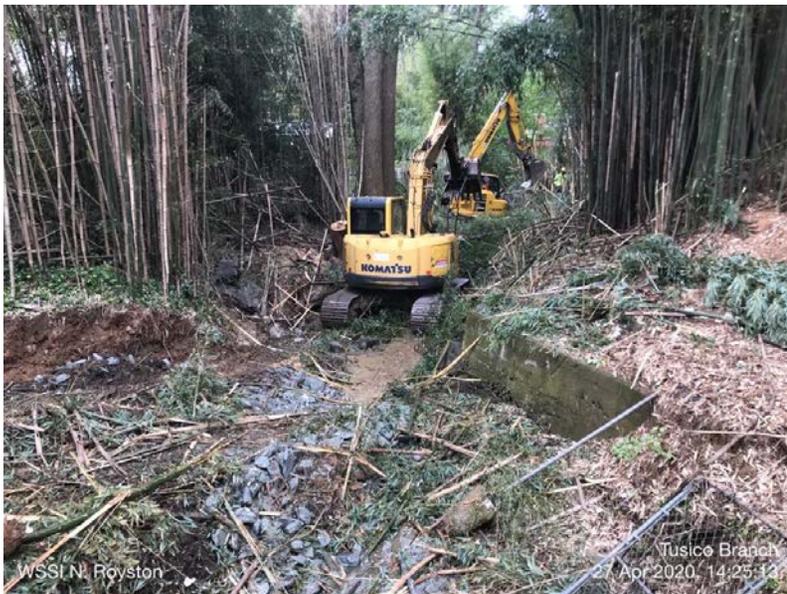
Removal of invasive bamboo to access work area.

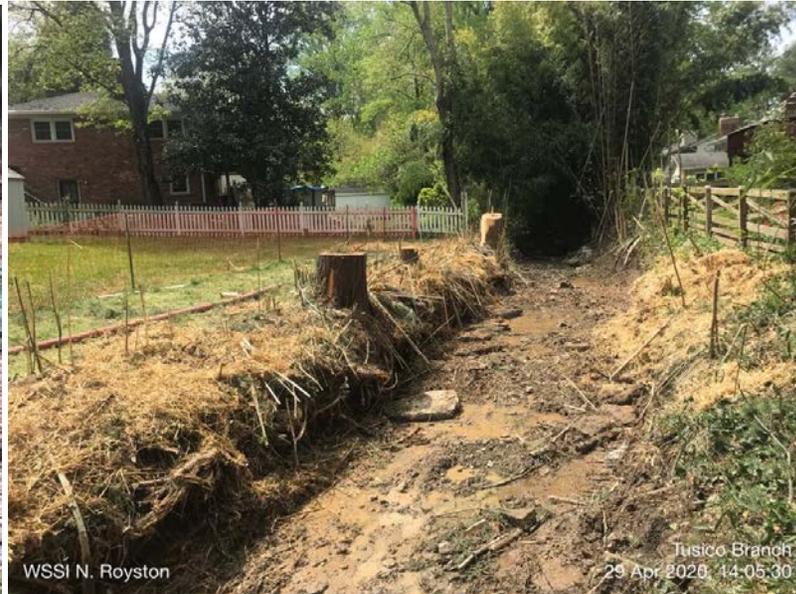
Following invasive bamboo removal. Access established.

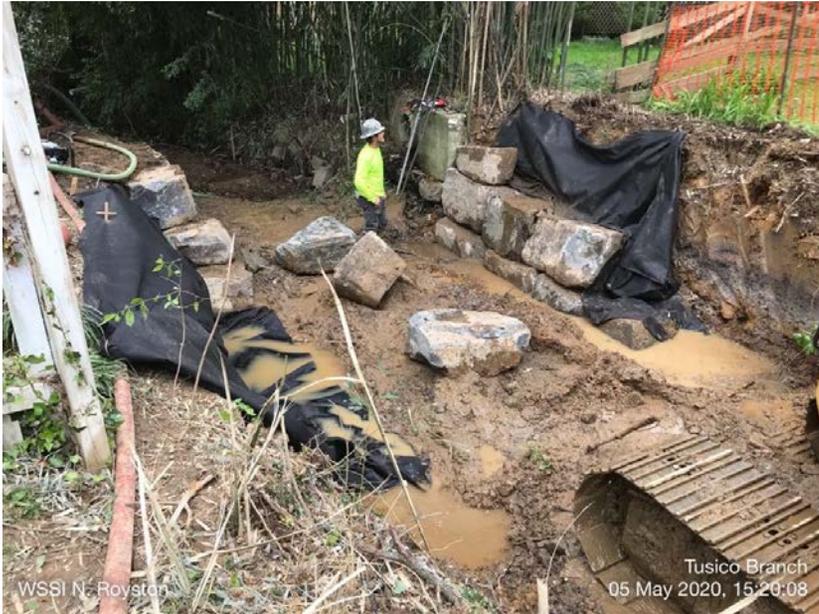
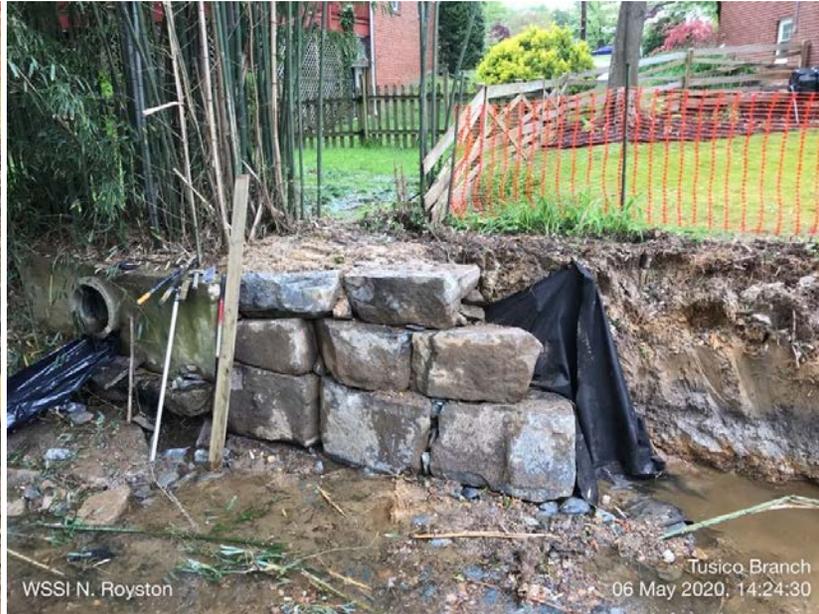
Stacked boulder wall construction was started on the west/upstream end of Area 4

Each piece needs to be shaped to fit closely with adjacent sections. A skilled operator is necessary to place these boulders.

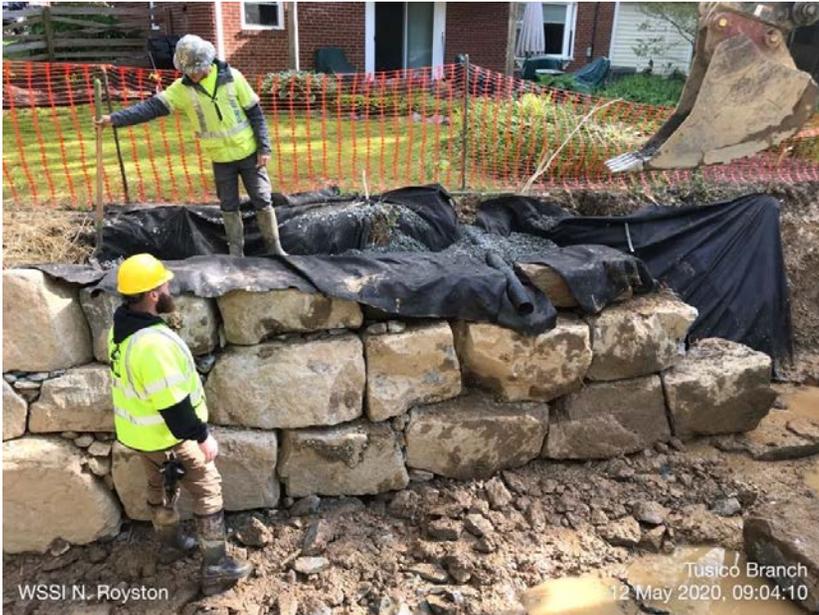
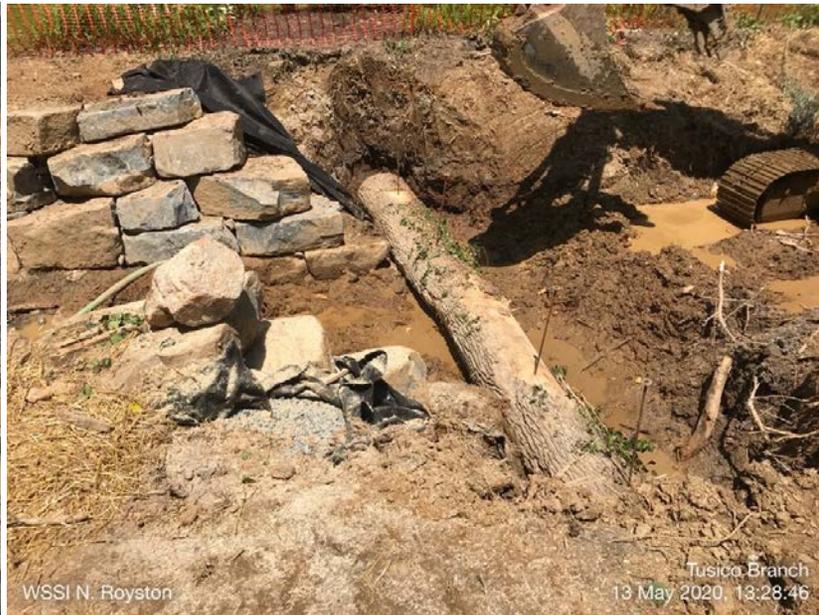
One of five log drops being installed. The logs are reused trees that were removed to allow for construction.

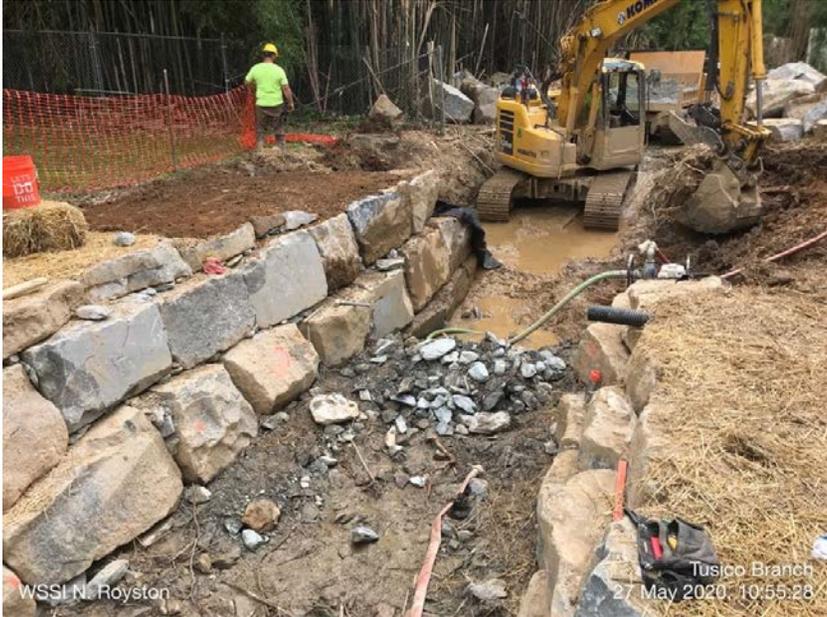
Construction of stone wall proceeding downstream

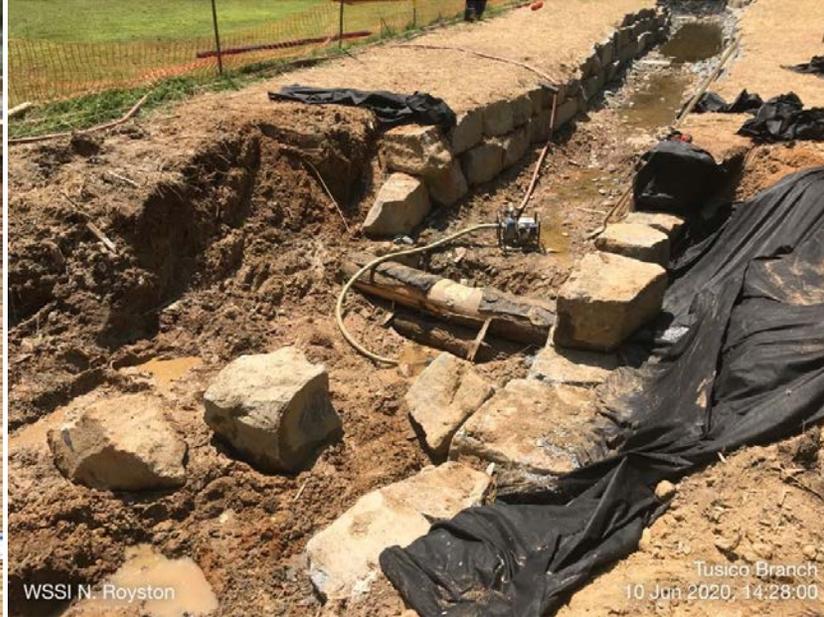
Installation of a log drop with construction of the boulder wall

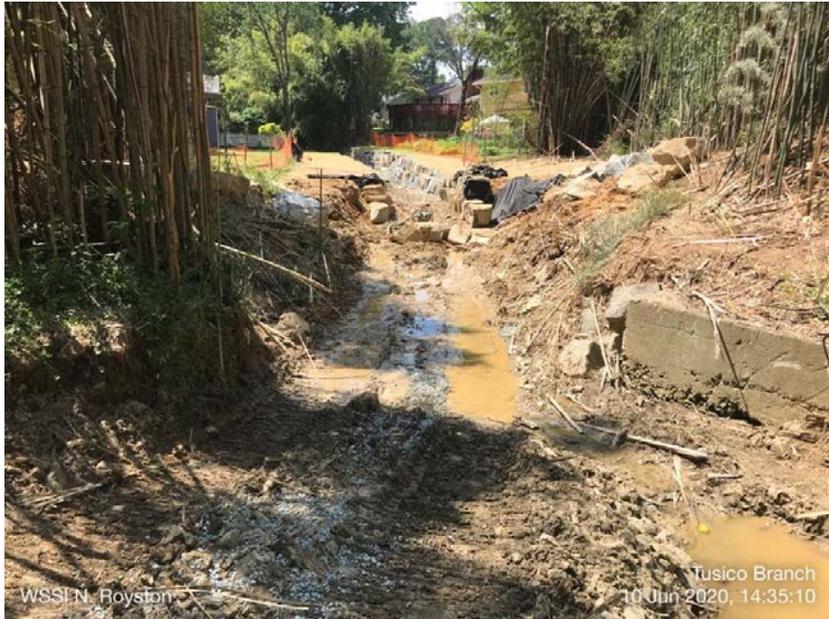
Completed sections of the wall can be seen in the background, with areas to be constructed in the foreground.

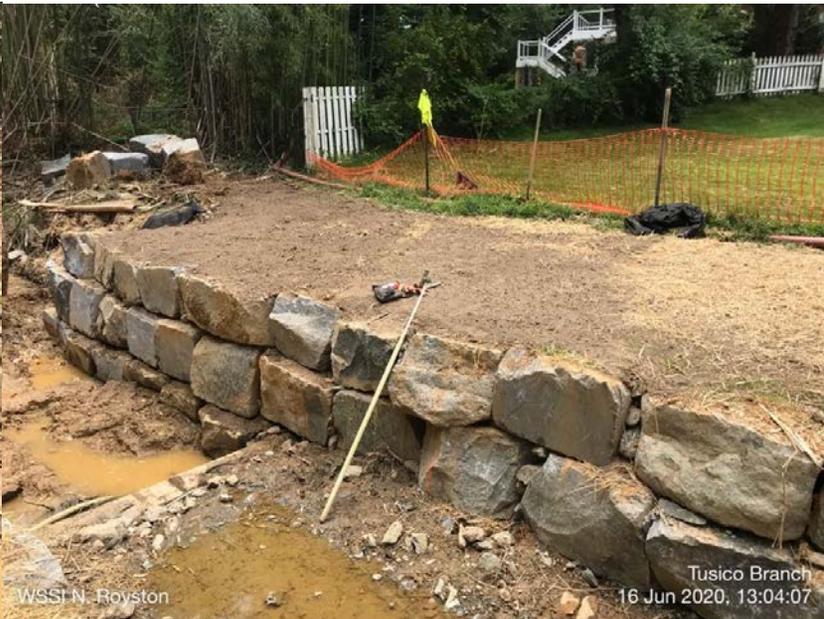
After construction of the wall and stabilization of the work area.
