## CITY OF FAIRFAX FIRE DEPARTMENT

# SIGNIFICANT ACCIDENT / INJURY INVESTIGATION

Two Firefighters Injured in Ladder Fall

April 29, 2013

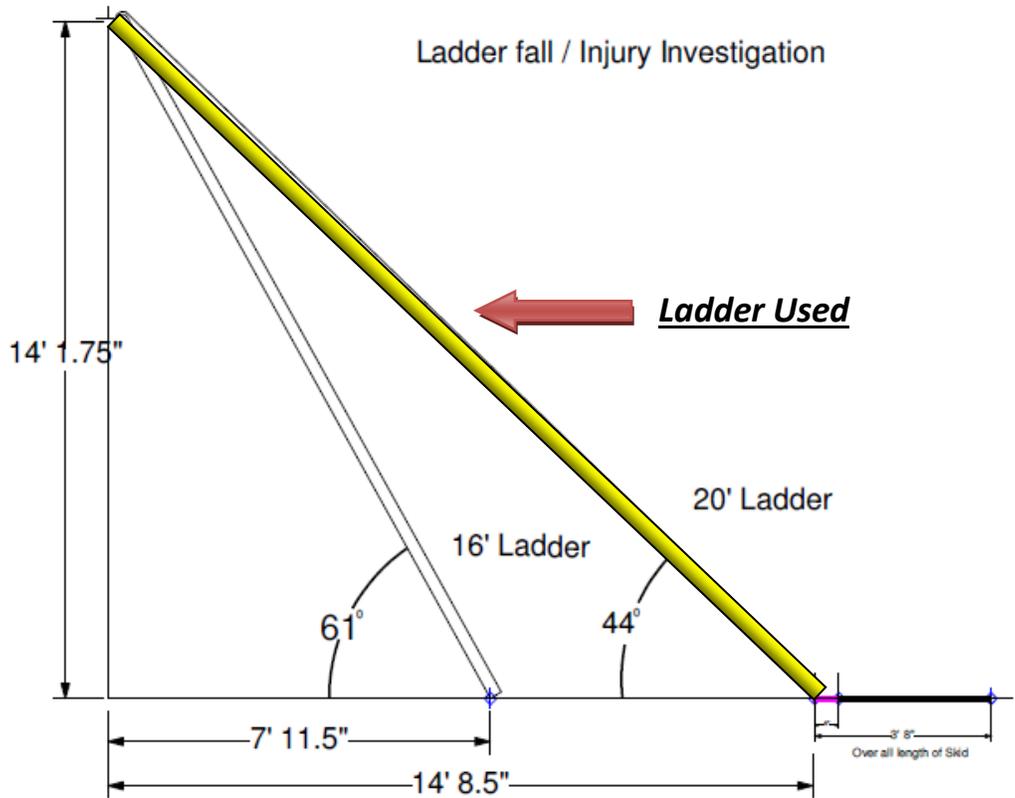
The instructor advised the crew to use a non-optimal ladder for this evolution. A 16' roof ladder would provide for a 61 degree climbing angle which is much closer to the industry recommended 75 degrees for climbing and working from.

Illustration 1 - Calculated Angle of 20' ladder compared to 16' ladder

Two separate laddering evolutions should be identified clearly differentiating one for VEIS and one for bailouts. Instructors should use scenarios that maximize safety to teach points. This should be documented in the lesson plan for training and delivered to the entire department.

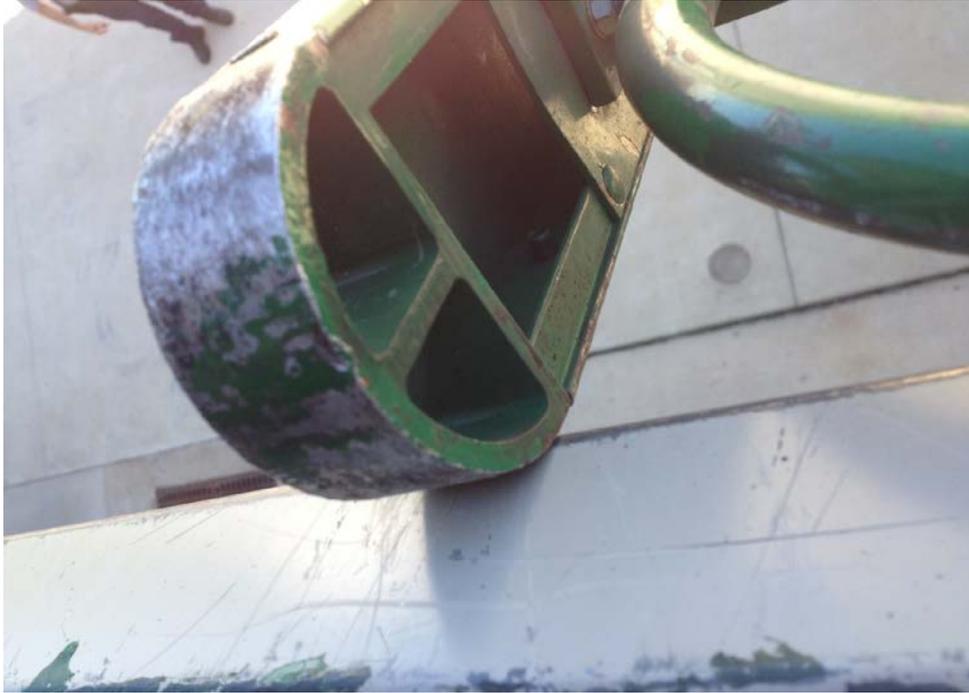
The rounded portion of the tip was the only point of contact with the window sill which is sloped at a 45 degree angle. This resulted in minimal ladder / sill contact.

Photograph 1 – Right beam/tip contact with window trim

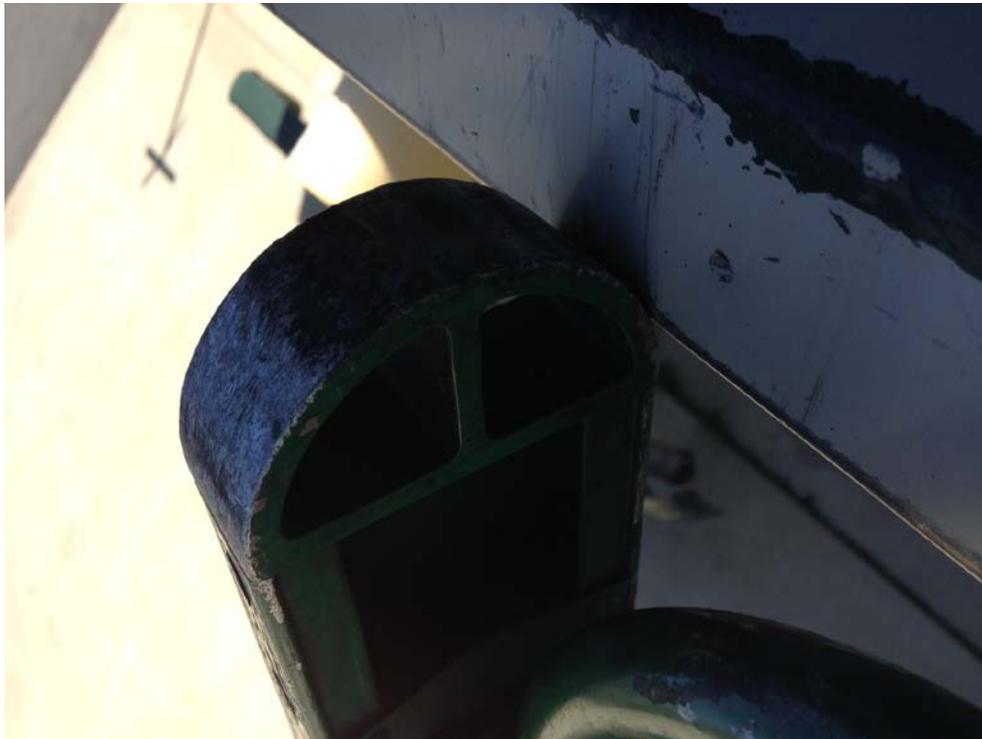
Photograph 2 - Left beam/tip contact with window trim

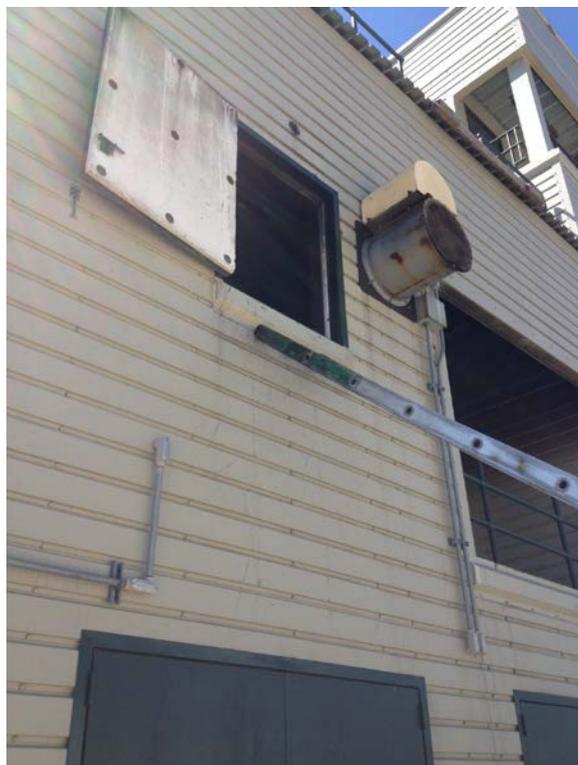
Photograph 3 – Position of ladder after first drop

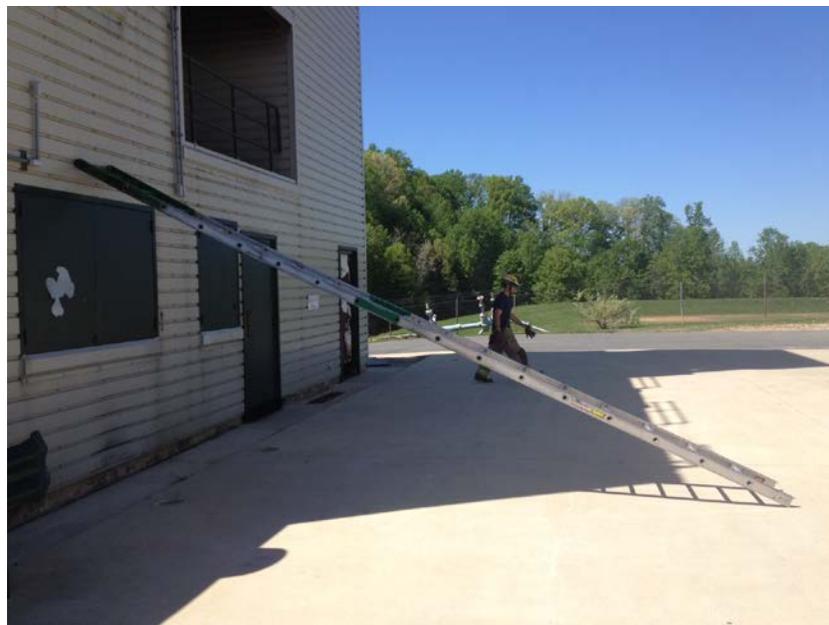
Photograph 4 – Position of ladder where ladder butt became airborne

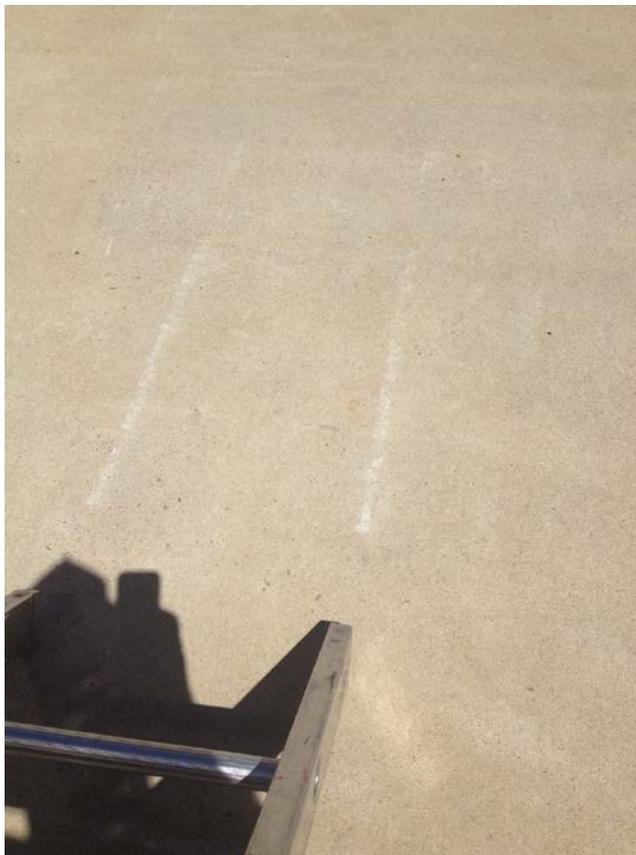
Photograph 5 – 3'8" of skid marks on concrete

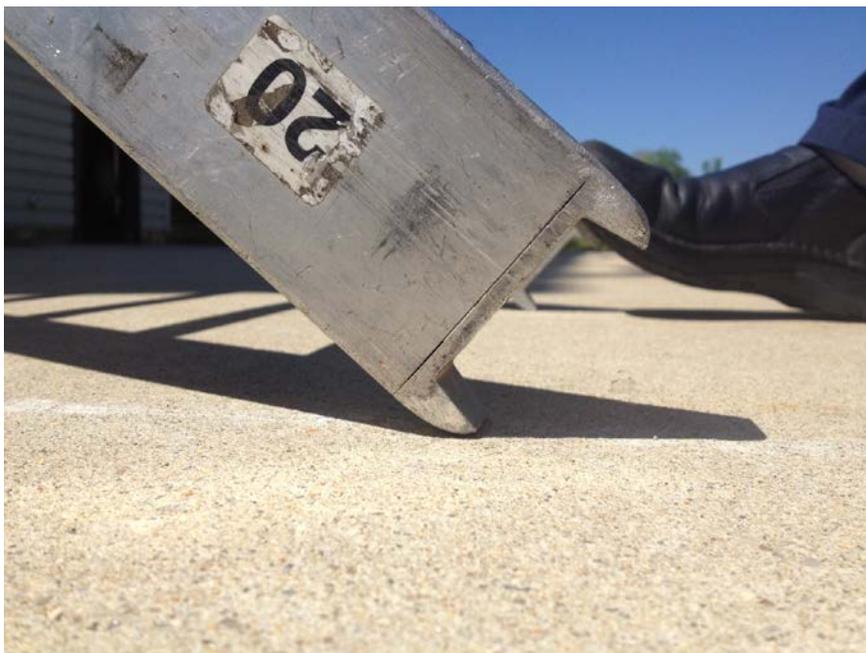
Photograph 6 – Position of ladder butt when unrestrained skid started

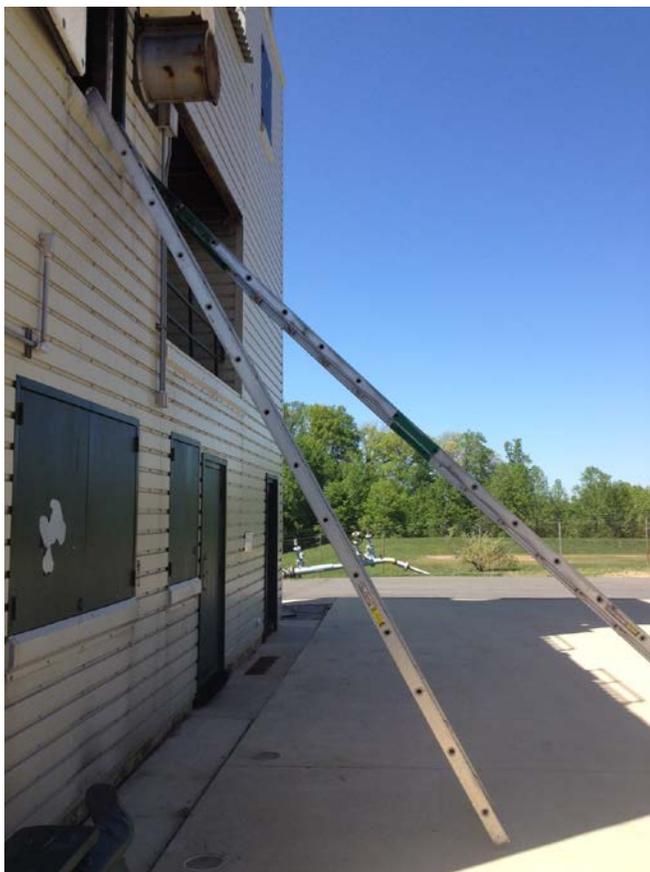
Photograph 7 – Ladder angle comparison between 16' and 20' ladders
