CITY OF FAIRFAX OLD TOWN HALL
PHASE 2 REHABILITATION

Historic Interior Finish Analysis Report

April 8, 2024

Historic Finish Analysis

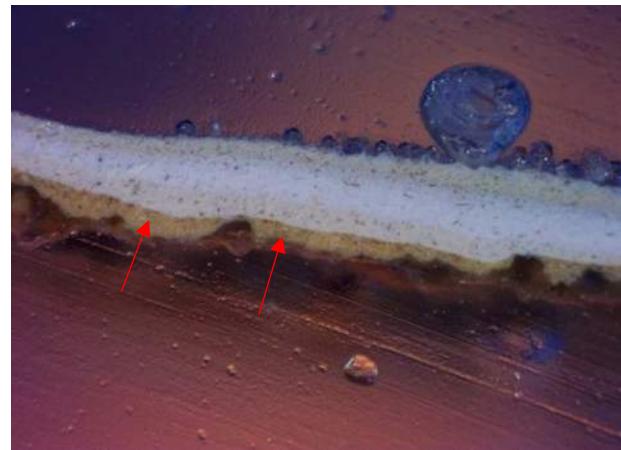
Microscopic sample analysis revealed that the substrate layer, a light orange-brown plaster, is likely the first period finish scheme for the entirety of the interior of FOTH. Under the microscope, large flecks of brown and red pigment are visible in the plaster substrate. The intentional pigmentation of plaster and lack of a traditional, lime-rich finish coat as part of the three-coat plaster system appears intentionally designed to create a wall finish complimentary to the large, dark wood beams in the building. The initial use designation of the building was multi-purpose and meant to host a variety of community social gatherings as well as serve as the meeting place for Henry Lodge No. 57, a local Masonic chapter. Between 1900 and 1960, the masonic chapter met in the second floor Assembly Hall (205). This follows a traditional pattern of Masonic Lodges in this time period, during which they were typically located in the upper floors of multi-use structures. Masonic lodges located in multi-use buildings did not normally have elaborate interior wall finishes, instead relying on interior furniture layouts to convey the intended use of the space.¹ The existing finishes sampled suggest that a similar lack of differentiation of interior wall finishes was likely for the second-floor Assembly Hall (205) that housed the masonic hall during the first period.

Figure 1: Photomicrograph of sample 28 taken from the 2nd floor Assembly Hall (205). Plaster layer denoted by red arrows.

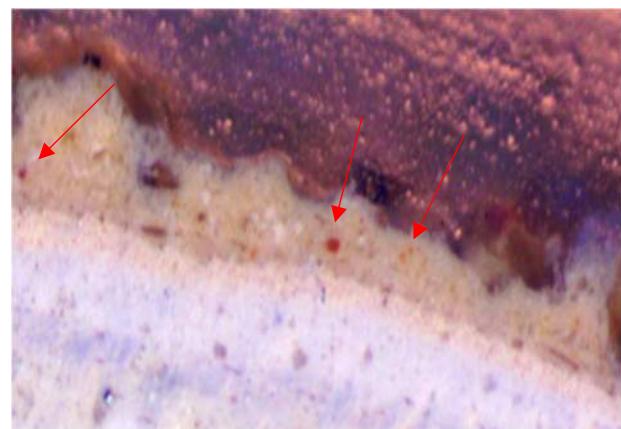
Figure 2: photomicrograph of sample 25 taken from the 2nd floor Assembly Hall (205). Pigment particles in plaster are denoted with red arrows.

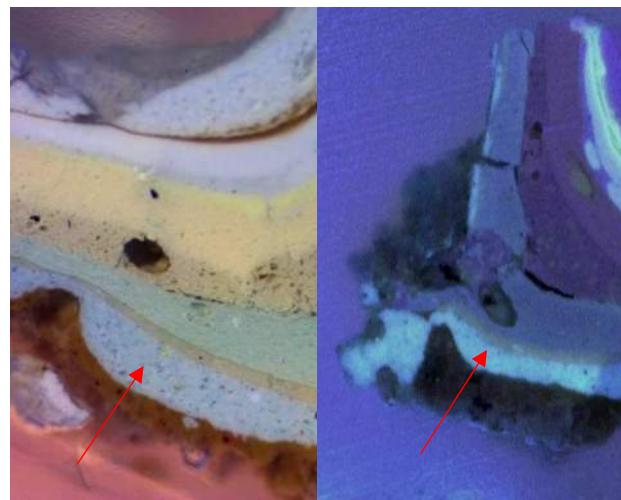
The second paint scheme features a pale, greyish blue that is applied directly to the orange-brown plaster. This paint layer is located in the first-floor Entry Vestibule (100), first-floor Assembly Hall (104), and second-floor Bride's Room (201). In this scheme, the second-floor Entry Vestibule (202) and Assembly Hall (205) likely remained finished with the orange-brown plaster identified in Scheme 1 since their primary use as the Masonic Hall made their finish updates separate from those carried out in the remaining portions of the building. The greyish blue paint was applied in a single, often thick layer, and does not appear to be self-leveling. The paint is pigment-rich, with many flecks of dark blue pigment identified during microscopy. Under ultraviolet light the layer fluoresces brightly, indicating it is bound in linseed oil.

Figure 4: Photomicrograph of sample 4 taken from the 1st floor Entry Vestibule (100) pictured in visible and UV light.

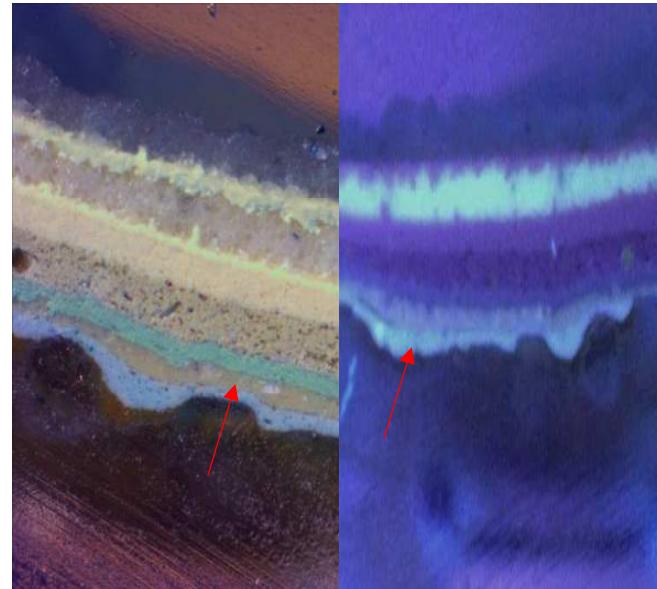
The third paint scheme in FOTH was a light yellowish-tan/pale yellow color. Similar shades are found throughout the entirety of the interior rooms in the building, ushering in a second period of uniformity in the building. The paint varies in thickness, and has large dark-brown pigment dispersed throughout. When observed using an ultraviolet microscope, the paint fluoresces very faintly, suggesting it is oil bound.

Figure 6: Photomicrograph of sample 2 taken from the first-floor Entry Vestibule (100) in visual light and UV.

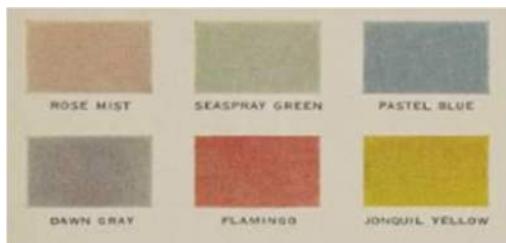
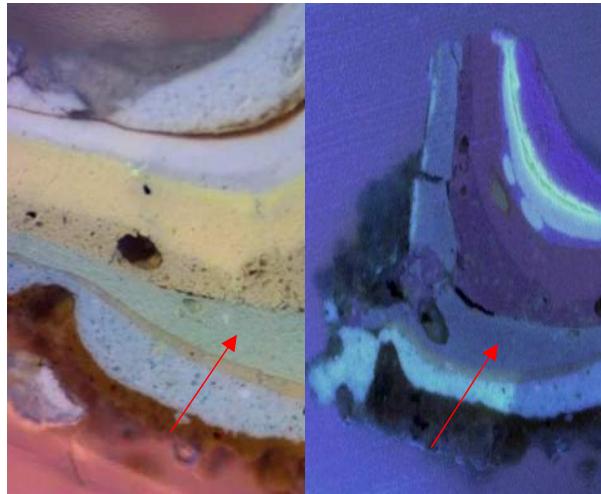
The fourth paint scheme identified was a light-greyish green color located in the first-floor Entry Vestibule (100) and the ceiling of the first-floor Assembly Hall (104). The remaining sample areas likely retained their light-yellowish tan paint color during this period. At 40x magnification, the paint appeared to be well-mixed and largely homogeneous with minimal discernable pigment. By the 1960s, latex paints had been available in the American marketplace for nearly twenty years and were widely commonly used. The smooth texture of the paint coupled with a lack of fluorescence beneath UV light suggests that this paint layer is a latex or acrylic paint. This layer also signals the shift to modern paint formulas at FOTH.

Figure 8: Photomicrograph of sample 4 taken from the 1st floor Entry Vestibule (100) pictured in visible and UV light.

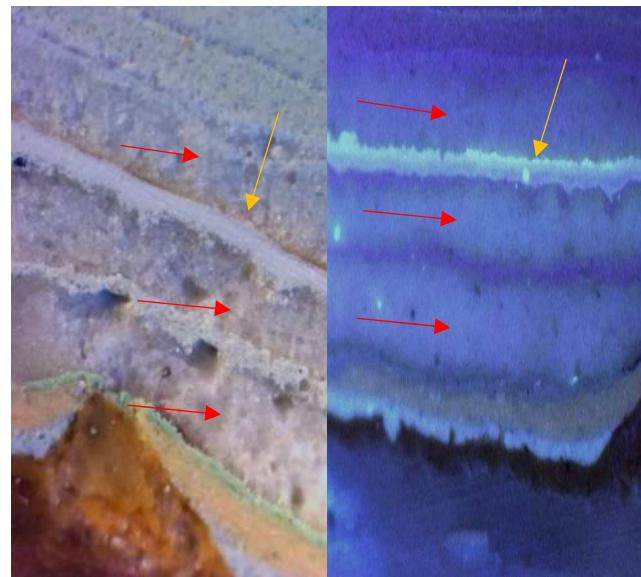
This scheme is currently visible and encompasses many modern paint layers. There were several campaigns of neutral paint application in shades of beige, pinkish white, and bright white. In many instances throughout the building, samples showed signs of multiple applications of plaster skim coats followed by neutral paints. Some of these campaigns also included oil-based plaster preparation layers, which appeared as a thin, semi-translucent, moderately yellowish-brown layer. When observed under UV light, these preparation layers fluoresced brightly. Others included layers of bonding agent, a product that allows plaster application directly on its surface. These layers appeared bright yellow, and bled into the adjacent plaster layers. Under UV light, these layers fluoresced brightly. The paints in this scheme are characterized by their relatively smooth texture and regular dispersion of pigments. These paints also appear flatter due to their self-leveling properties. Under UV light, these paints do not fluoresce.

Figure 10: Photomicrograph of sample 6 taken from the first-floor entry vestibule (100) pictured in visible and UV light. Red arrows indicate plaster layers and orange arrow indicates plaster prep layer.

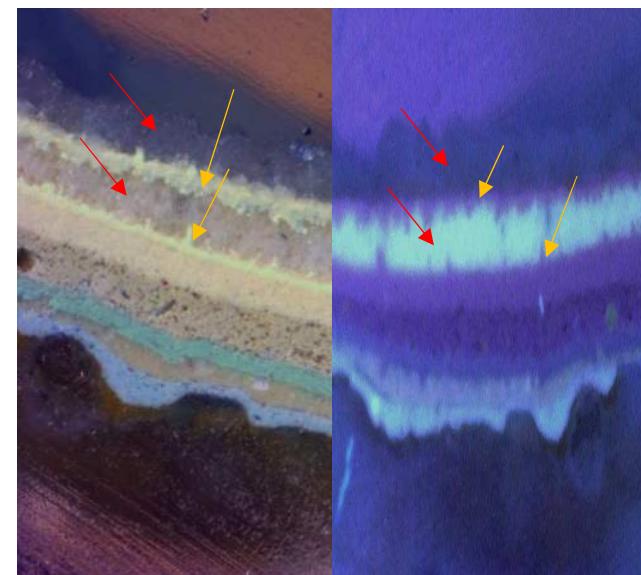
Figure 11: Photomicrograph of sample 3 taken from the first-floor entry vestibule (100) pictured in visible light and UV light. Red arrows indicate plaster layers and orange arrows indicate Plaster Weld adhesive.

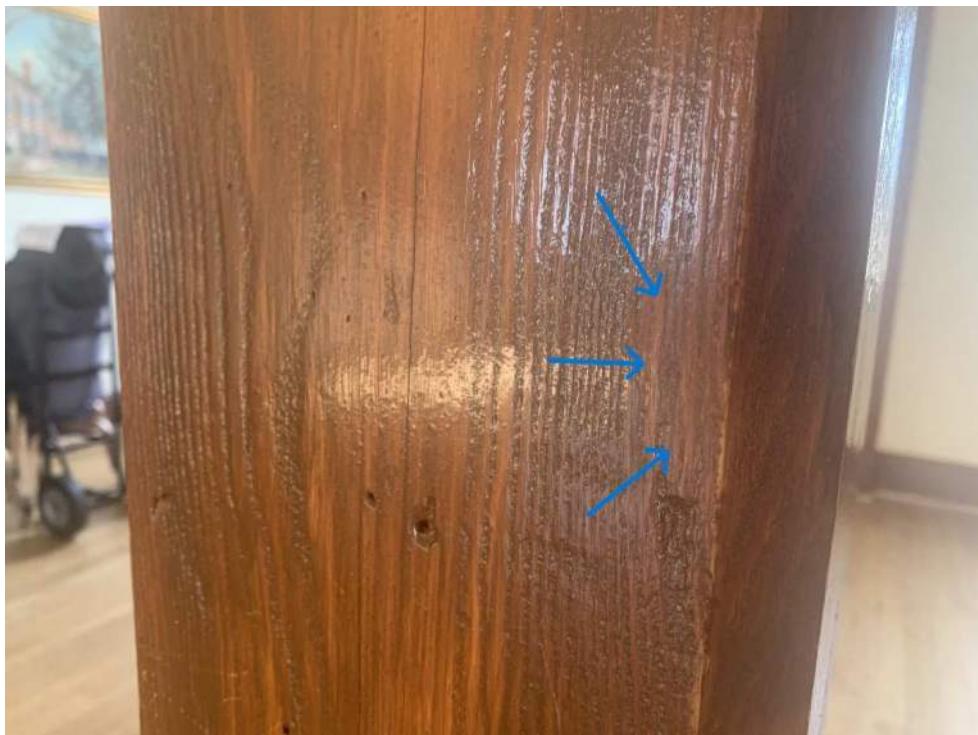
The tests found evidence of only one instance of shellac on the door to the first-floor Office (102). An oil finish was definitively detected on the second floor on the floor of the Bride's Room (201). The Bride's Room (201) has not been subjected to major renovations or repairs, so the oil finish in this room may be original. The exterior side of the first-floor door to the Entry Vestibule (100) may have been an oil finish, though the oil did not fully absorb into the wood. The other tests on the door were inconclusive, indicating that the finish may be very thin from wear over time. The results on a number of surfaces were inconclusive indicating that the remaining finish may be too thin to produce a visible reaction. Many of the elements, including doors, window frames, and the columns, currently have a lacquer finish, evidenced by the dull mark left behind following rubbing with acetone. MTFA recommends further investigation using infrared (FT-IR) microscopy to confirm the findings determined during solvent testing.

Figure 12: Solvent test results on first-floor Assembly Room (104) column indicating lacquer finish. The test area appears dull where the acetone was applied to the surface.

New wood finishes applied during restoration should reflect the solvent test findings. Lacquer was the most prevalent finish in FOTH, and it is recommended that a nitrocellulose lacquer be used to re-finish window frames, doors, columns, and the stair rail. Nitrocellulose lacquers are low-voc and are best applied with spray application methods. The oil finish on the wood floor identified in the Bride's Room (201) is believed to be original. MTFA recommends refinishing the floors in the building with an oil-based wood finish, like tung oil, that will penetrate into the wood while maintaining its historic character.

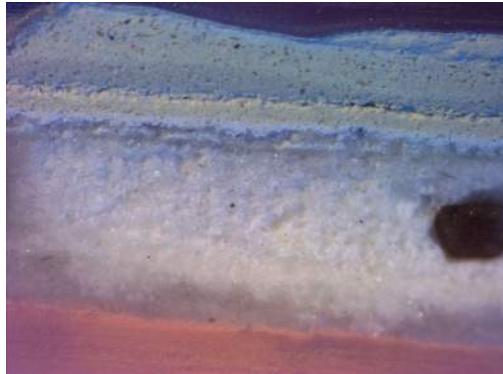
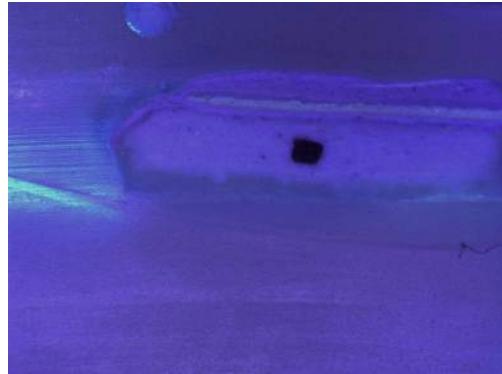
Location of Sample: East wall

Comments: Color of plaster substrate indicates this area may have been patched or replaced at some time.

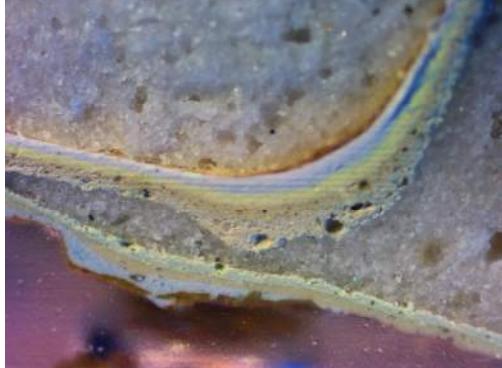
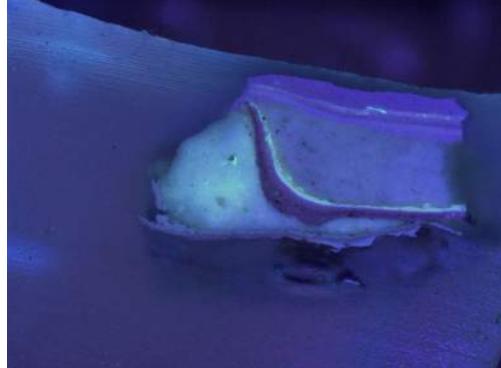
Project:	Fairfax Old Town Hall		
Room Name:	1st Floor Entry Vestibule	Location of Building:	Fairfax, Virginia
Sample Number:	2	Element Type:	Flat Plaster
Location of Sample:	East wall

Photomicrograph: Prepared on 03/15/2024
(Visible Light: 4X Magnification)

Photomicrograph: Prepared on 03/15/2024
(Ultra-Violet Light)

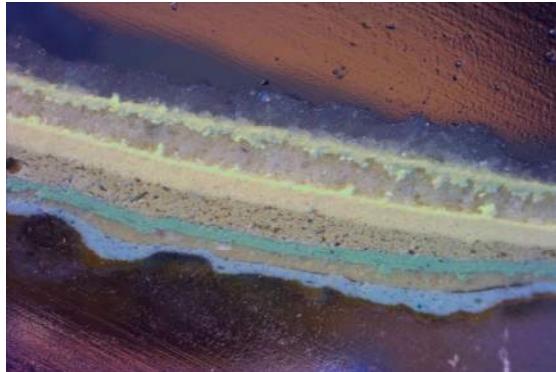
Sample Number: 3 Element Type: Flat Plaster

Photomicrograph: Prepared on 03/05/2024
(Visible Light: 4X Magnification)

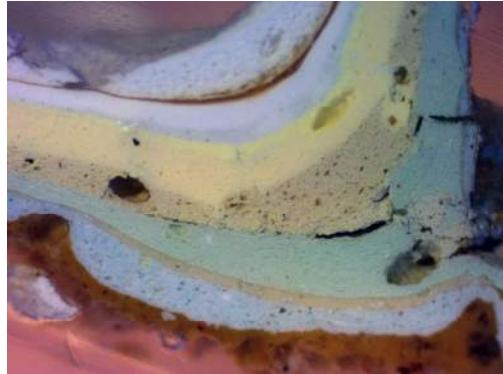
Sample Number: 4 Element Type: Flat Plaster

Photomicrograph: Prepared on 03/15/2024
(Visible Light: 4X Magnification)

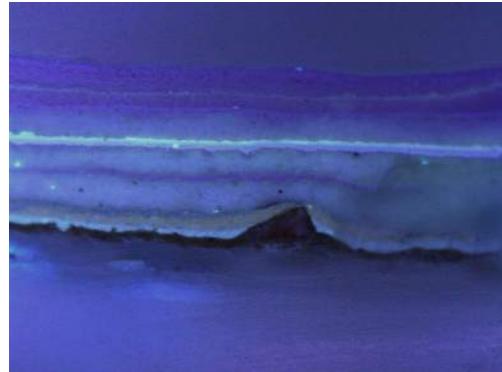
Photomicrograph: Prepared on 03/05/2024
(Ultra-Violet Light)

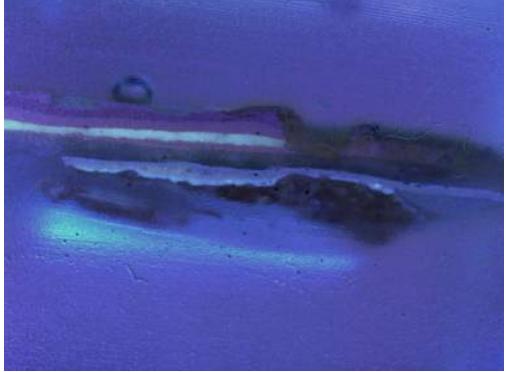
Project:	Fairfax Old Town Hall						
Room Name:	1st Floor Entry Vestibule	Location of Building:		Fairfax, Virginia			
Sample Number:	7	Element Type:		Flat Plaster			
Location of Sample:	Beneath window on west wall

Photomicrograph: Prepared on 03/15/2024 (Visible Light: 4X Magnification)			Photomicrograph: Prepared on 03/15/2024 (Ultra-Violet Light)				
Paint Seriation Chart							
Layer Number	Descriptive Color Name	Layer Type	Layer Thickness	Munsell No.	RGB		
Substrate	Light Orangeish Brown Plaster	Plaster	N/A	10YR 5/6	230, 188, 149		
1	Pale Greyish Blue	Finish layer	+	7.5B 8/2	186, 203, 227		
2	Light Yellowish Tan	Finish layer	+	2.5Y 8.5/4	239, 228, 205		
3	Pale Greyish Green	Finish layer	-	2.5G 8/2	198, 224, 202		
4	Plaster	Plaster	++	N/A	N/A		
5	Pale Yellow	Finish layer	+	5Y 9/2	236, 229, 196		
6	Bright Pale Yellow	Primer/Adhesive	-	5Y 9/6	248, 229, 240		
7	Plaster	Finish layer	+	N/A	N/A

8	Bright Pale Yellow	Primer/adhesive	-	5Y 9/6	248, 229, 240		
9	Light Yellowish Tan	Finish layer	+	2.5Y 8.5/4	220, 198, 148		
10	Light Creamy Beige	Finish layer	+	2.5Y 9/2	239, 226, 197		
11	Smooth Bright White	Finish layer	-	N 9.0/	255, 255, 246		
12							
13							
14							
15							
16							
Technician:	Riley Morris		Date:	3/15/2024			
Comments:

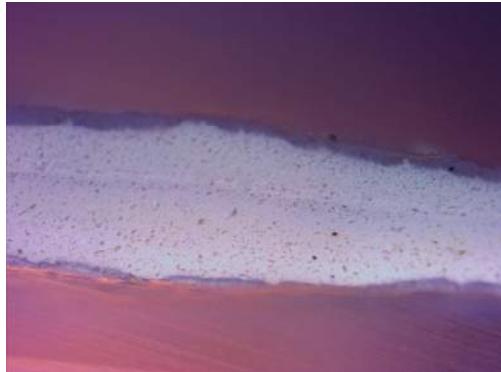
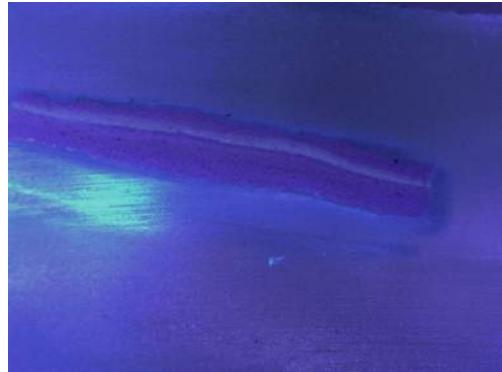
Location of Sample: North wall

Comments: Sample appears to have been taken from a repair area, hence the lack of brown plaster substrate. Sample should be considered incomplete.

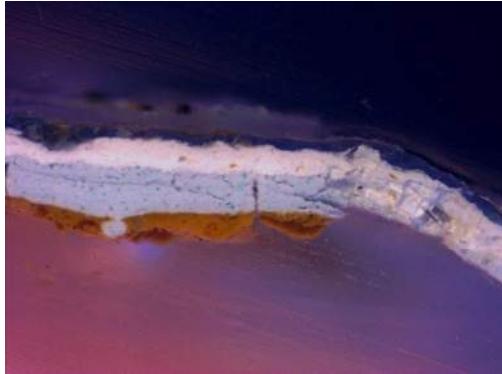
Location of Sample: North wall (#3)

Photomicrograph: Prepared on 03/05/2024
(Visible Light: 4X Magnification)

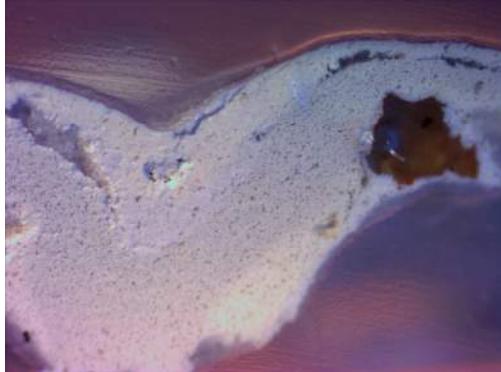
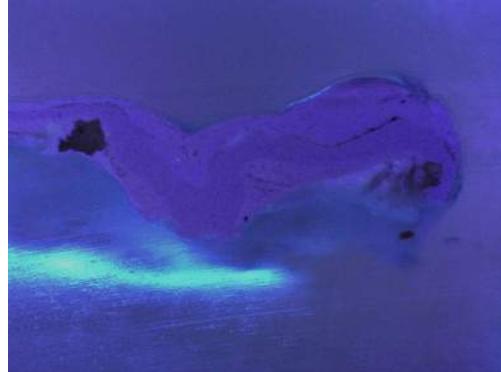
Location of Sample: South wall (#1)

Photomicrograph: Prepared on 03/05/2024
(Visible Light: 4X Magnification)

Photomicrograph: Prepared on 03/05/2024
(Ultra-Violet Light)

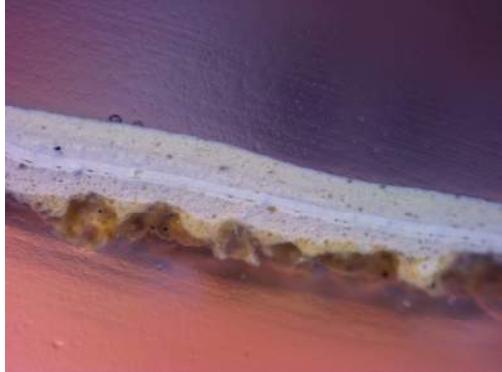
Location of Sample: East wall (#2)

Photomicrograph: Prepared on 03/15/2024
(Visible Light: 4X Magnification)

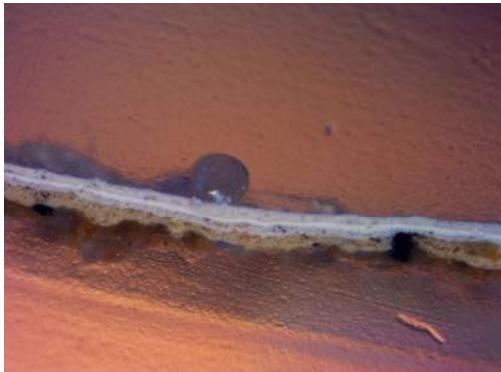
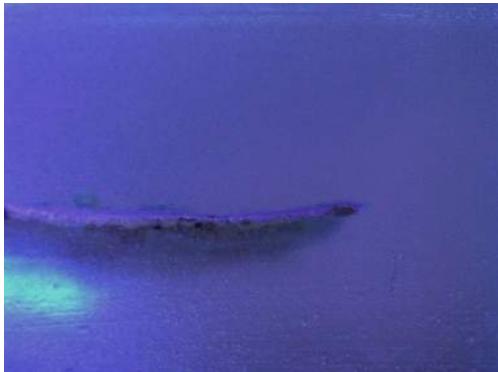
Location of Sample: North wall (#1)

Photomicrograph: Prepared on 03/15/2024
(Visible Light: 4X Magnification)

Photomicrograph: Prepared on 03/15/2024
(Ultra-Violet Light)

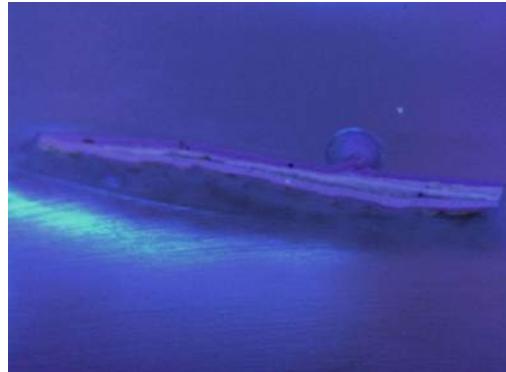
Photomicrograph: Prepared on 03/05/2024
(Ultra-Violet Light)

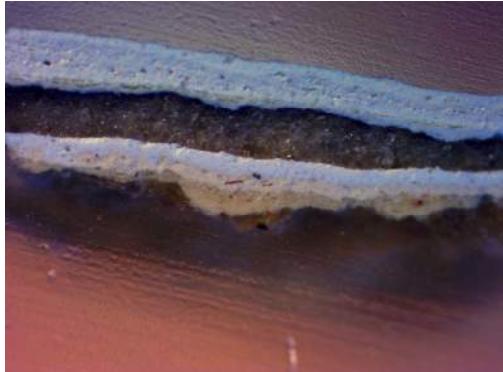
Location of Sample: North wall (#2)

Photomicrograph: Prepared on 03/15/2024
(Visible Light: 4X Magnification)

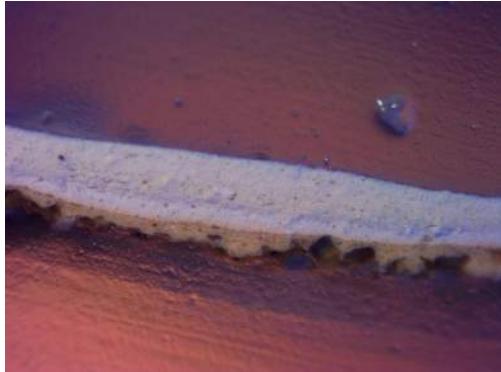
Sample Number: 25 **Element Type:** Flat Plaster

Photomicrograph: Prepared on 03/15/2024
(Visible Light: 4X Magnification)

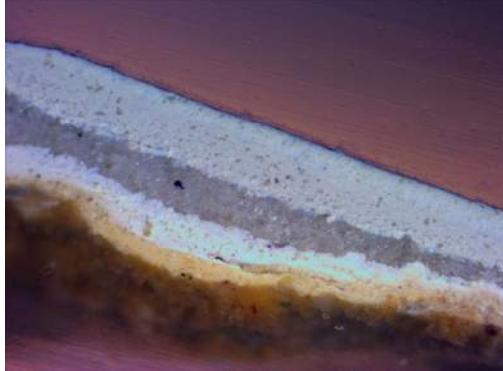
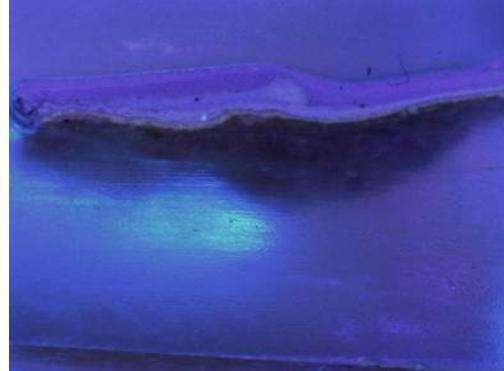
Location of Sample: East wall (#2)

Photomicrograph: Prepared on 03/15/2024
(Visible Light: 4X Magnification)

Photomicrograph: Prepared on 03/15/2024
(Ultra-Violet Light)

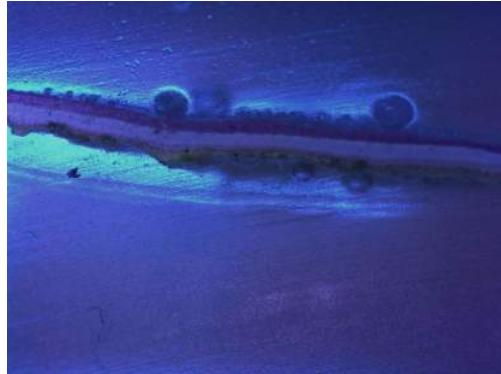
Photomicrograph: Prepared on 03/15/2024
(Ultra-Violet Light)

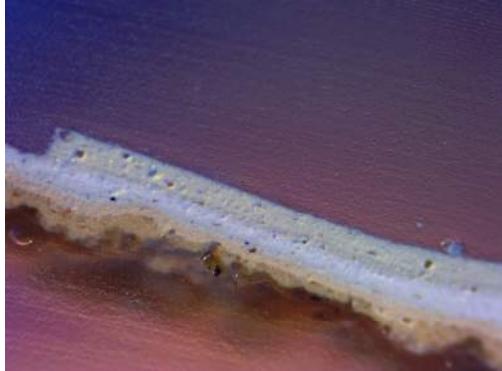
Sample Number: 30 **Element Type:** Flat Plaster

Photomicrograph: Prepared on 03/15/2024
(Visible Light: 4X Magnification)

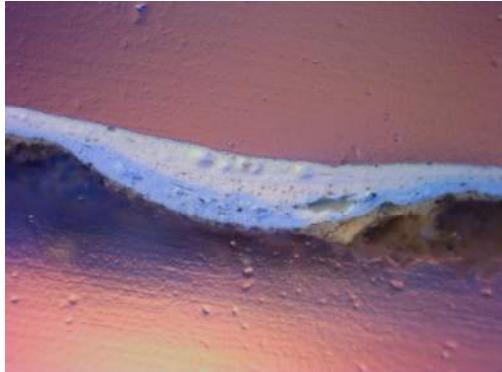
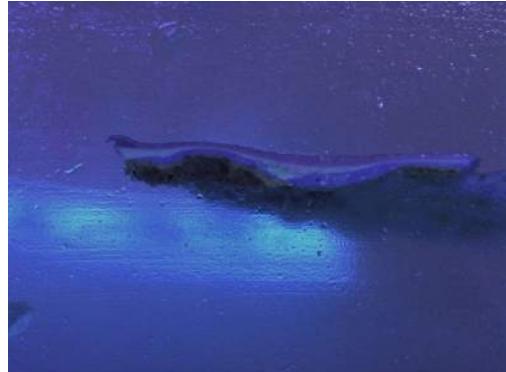
Sample Number: 34 **Element Type:** Flat Plaster

Photomicrograph: Prepared on 03/15/2024
(Visible Light: 4X Magnification)

Photomicrograph: Prepared on 03/15/2024
(Ultra-Violet Light)

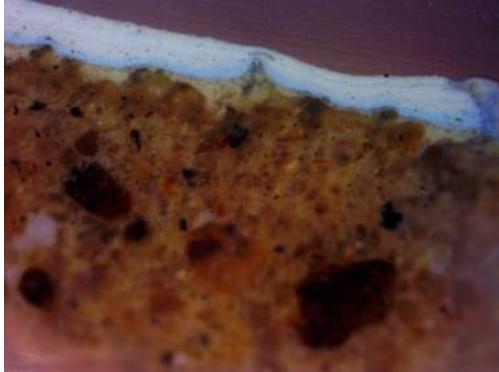
Sample Number: 36 Element Type: Flat Plaster

Photomicrograph: Prepared on 03/15/2024
(Visible Light: 4X Magnification)

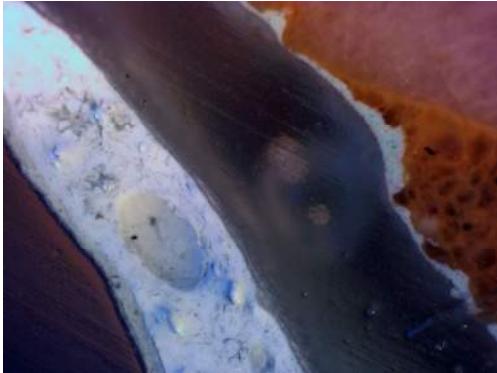
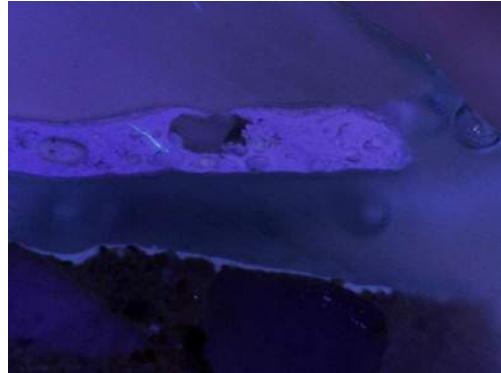
Location of Sample: Ceiling

Layer Number	Descriptive Color Name	Layer Type	Layer Thickness	Munsell No.	RGB
Substrate	Light Orangeish Brown Plaster	Plaster	N/A	10YR 5/6	230, 188, 149
1	Pale Greyish Green	Finish layer	-	2.5G 8/2	198, 224, 202
2	Textured, Bright White	Finish layer	++	N 9.0/	255, 255, 246
3					
4					
5					
6					
7					
8					
9					
10					
11					
12					
13					
14					
15
