Stream Restoration Project on Unnamed Tributary of Accotink Creek

Keith Ave. east to Chain Bridge Rd. bridge

June 28, 2016

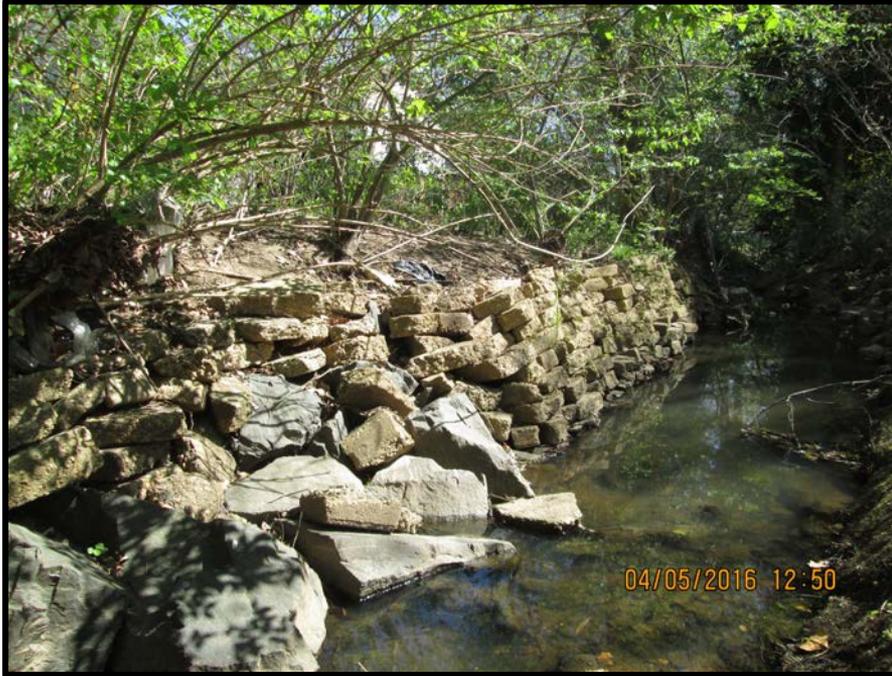
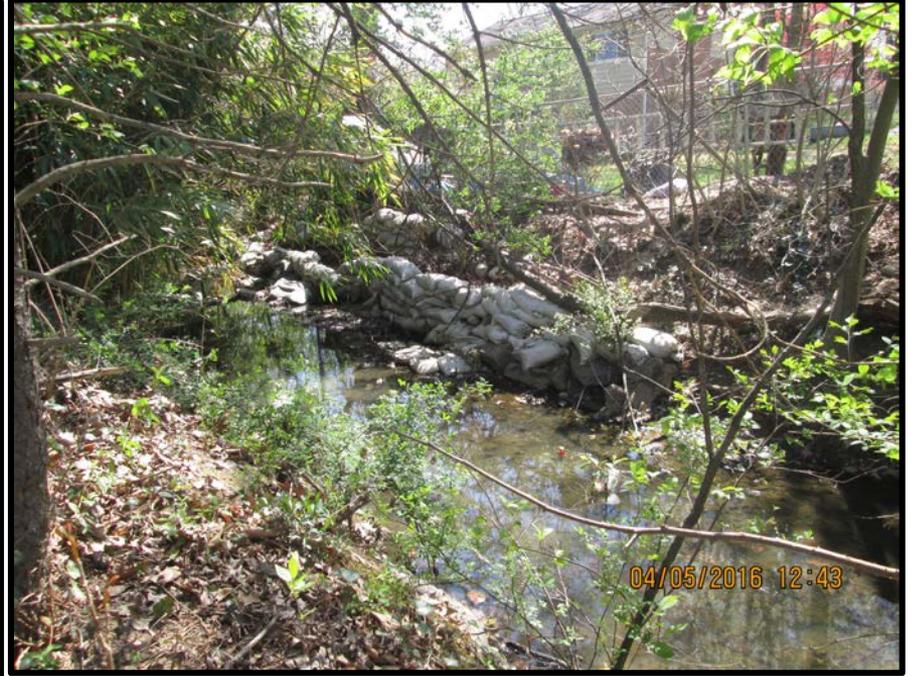
Existing Conditions of the Stream

Severe eroding has caused property line barriers to begin to collapse and fall into the stream. Continuous unstable erosion will lead to loss of private property.

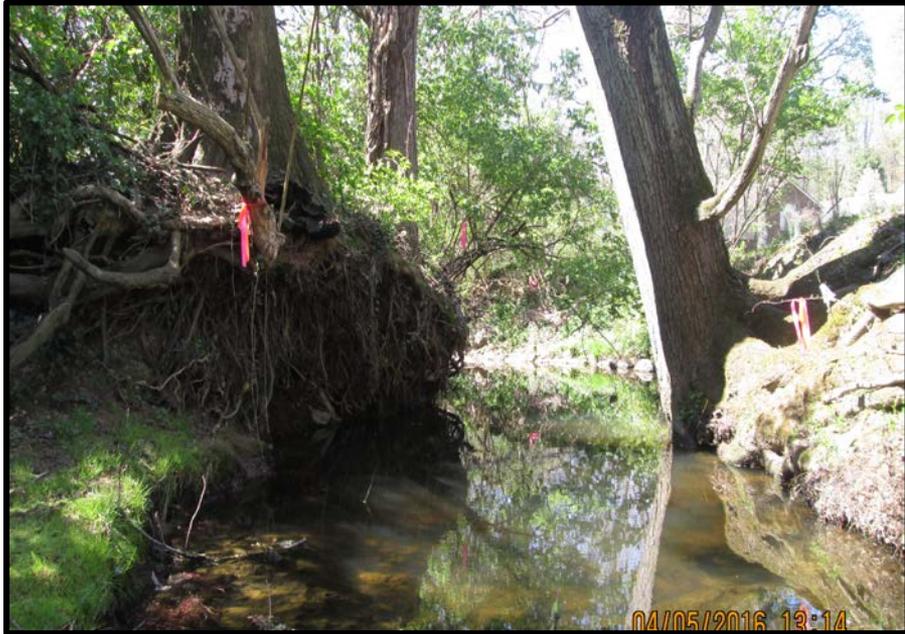
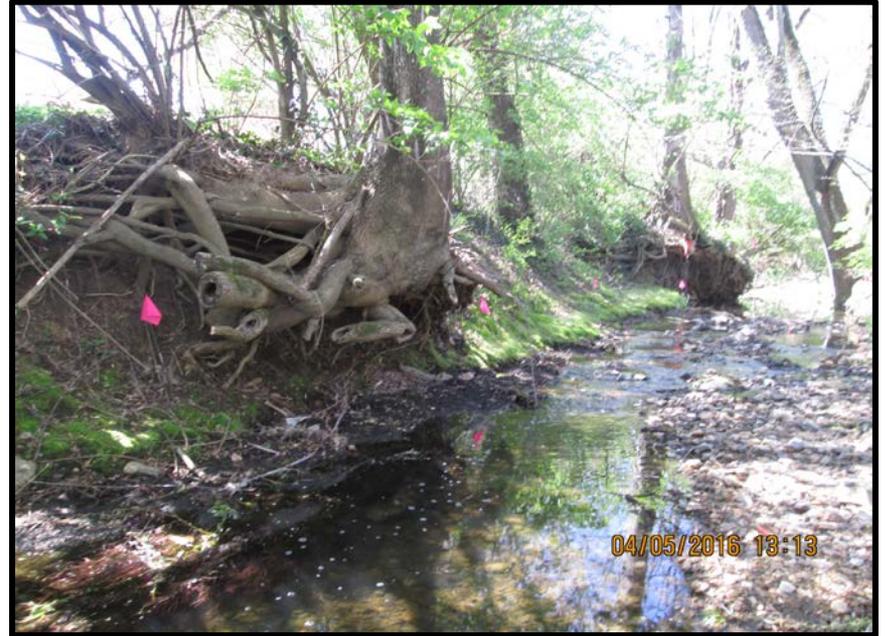
Existing Conditions of the Stream

Tree roots are exposed where the stream is eroding, making trees and associated stream banks unstable and dangerous.

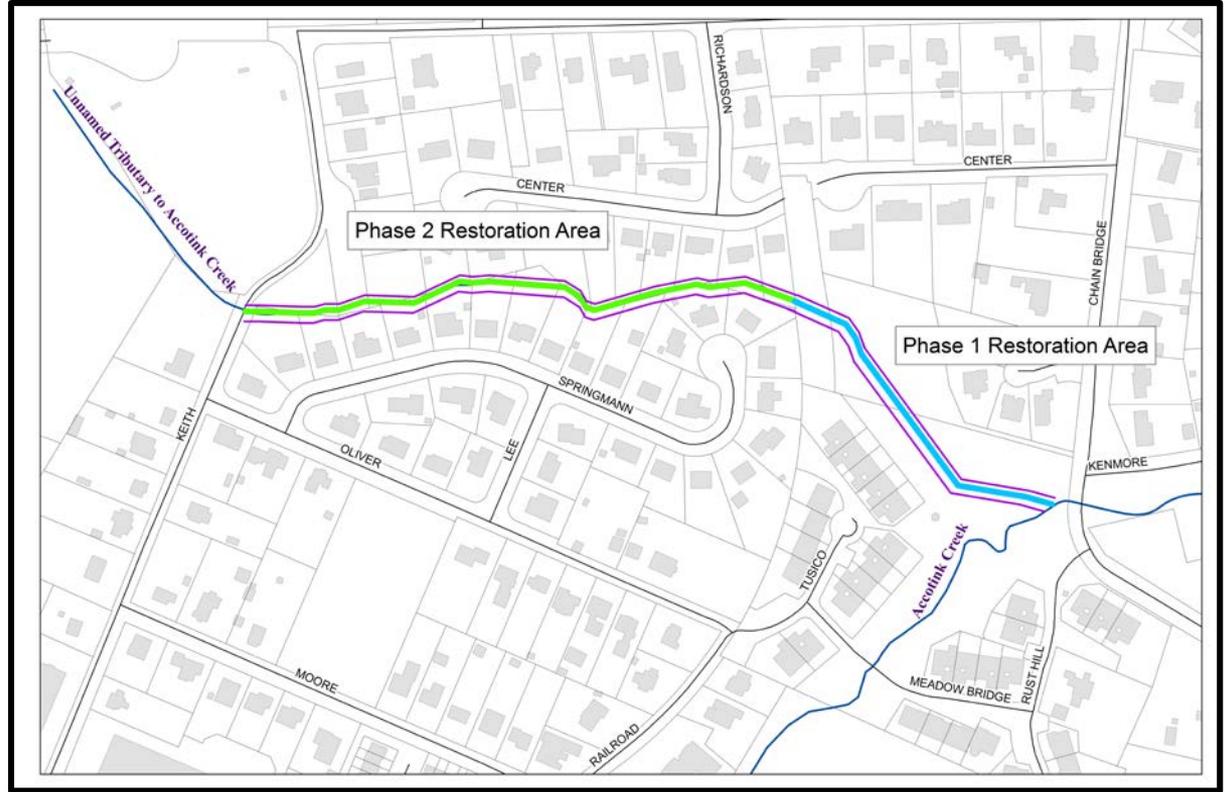
Phase I Project Scope

Approximately 600 linear feet of full restoration of the downstream section from the Chain Bridge Rd. bridge west along the Rustfield and Taba Cove neighborhood property lines (Blue)

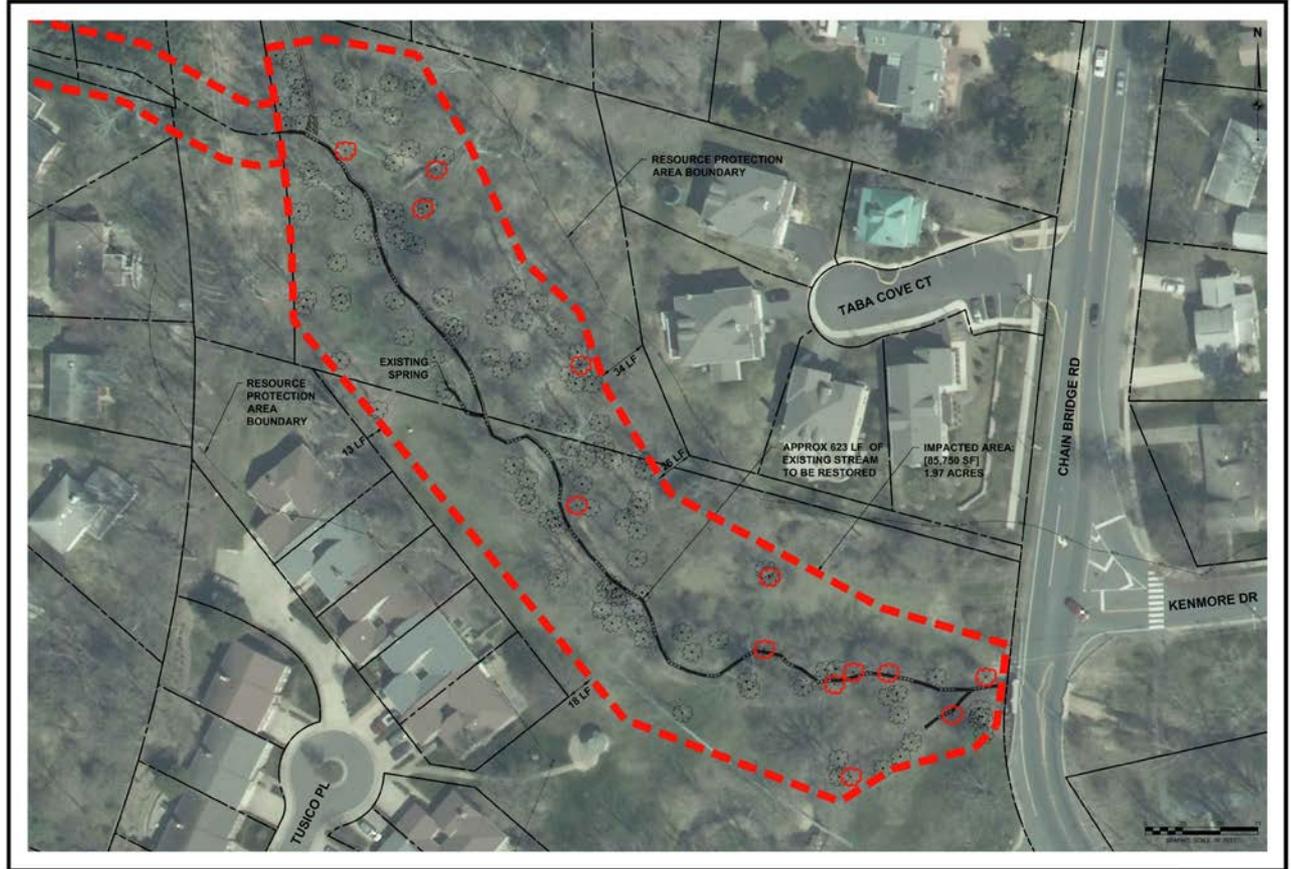
Impacts of Phase I

- Approx. 600 linear ft
- Approx. 100 ft wide project area
- Approx. 60,000 SF of private property
- Close proximity of 9 homes
- 136 trees located in project limits
- 13 dead trees

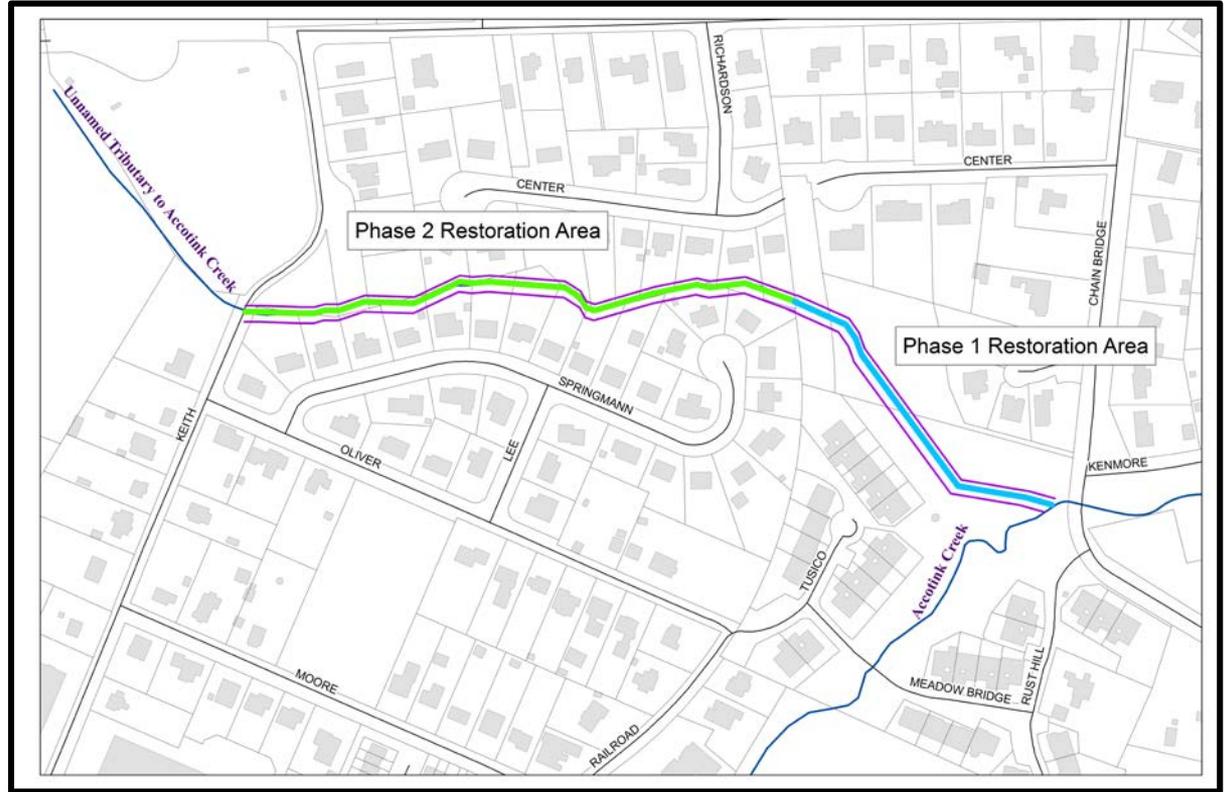
Phase II Project Scope

Approximately 1,300 linear feet of full restoration upstream from Phase I, west behind the residential homes located along Springmann Dr. and Center St., to Keith Ave. (Green)

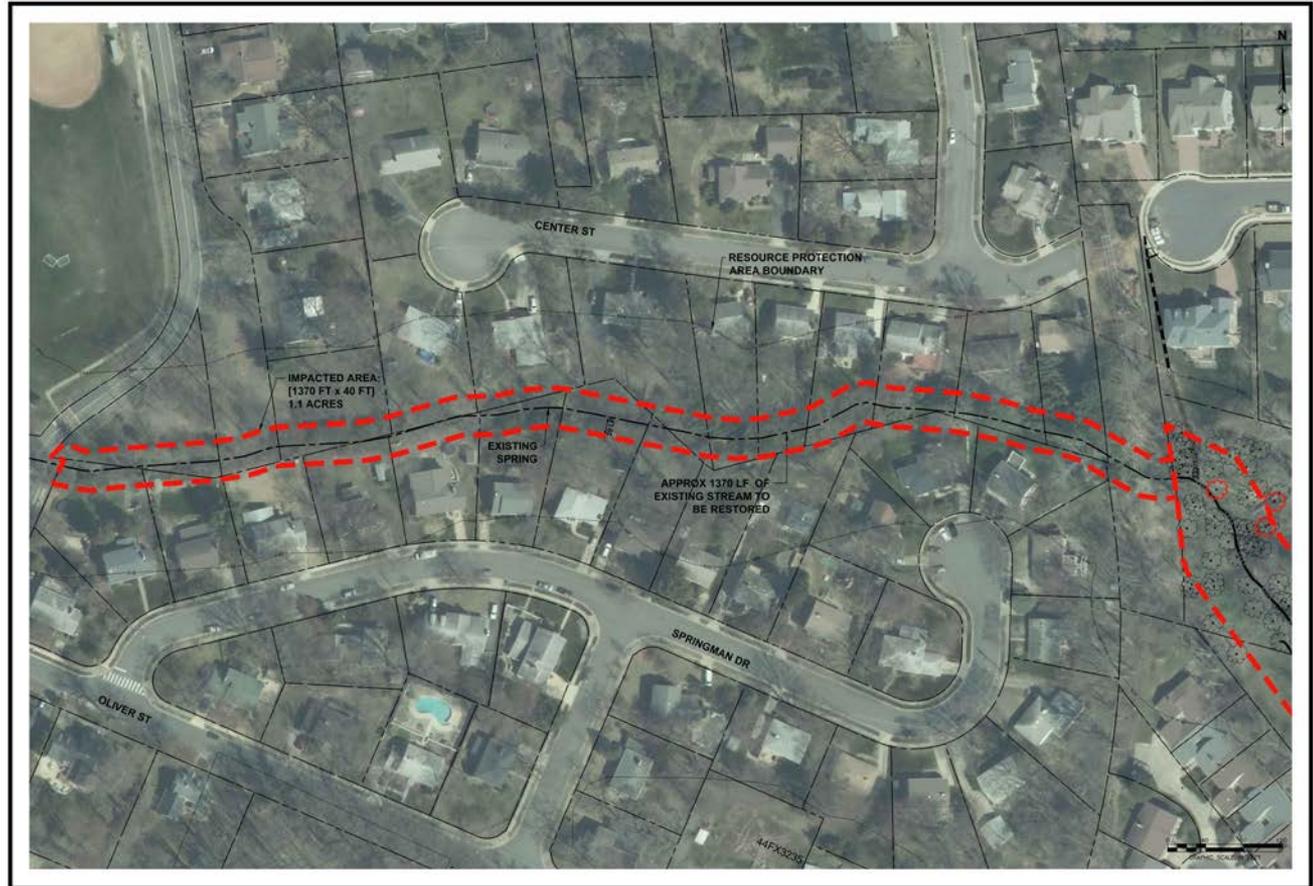
Impacts of Phase II

- Approx. 1,300 linear ft
- Approx. 40 ft wide project area
- Approx. 52,000 SF of private property
- Close proximity of 26 homes
- Tree Survey in progress
